## OFAPARS` V TWINS.

### **Lethargic starter motor.**

### 650 starter motor.

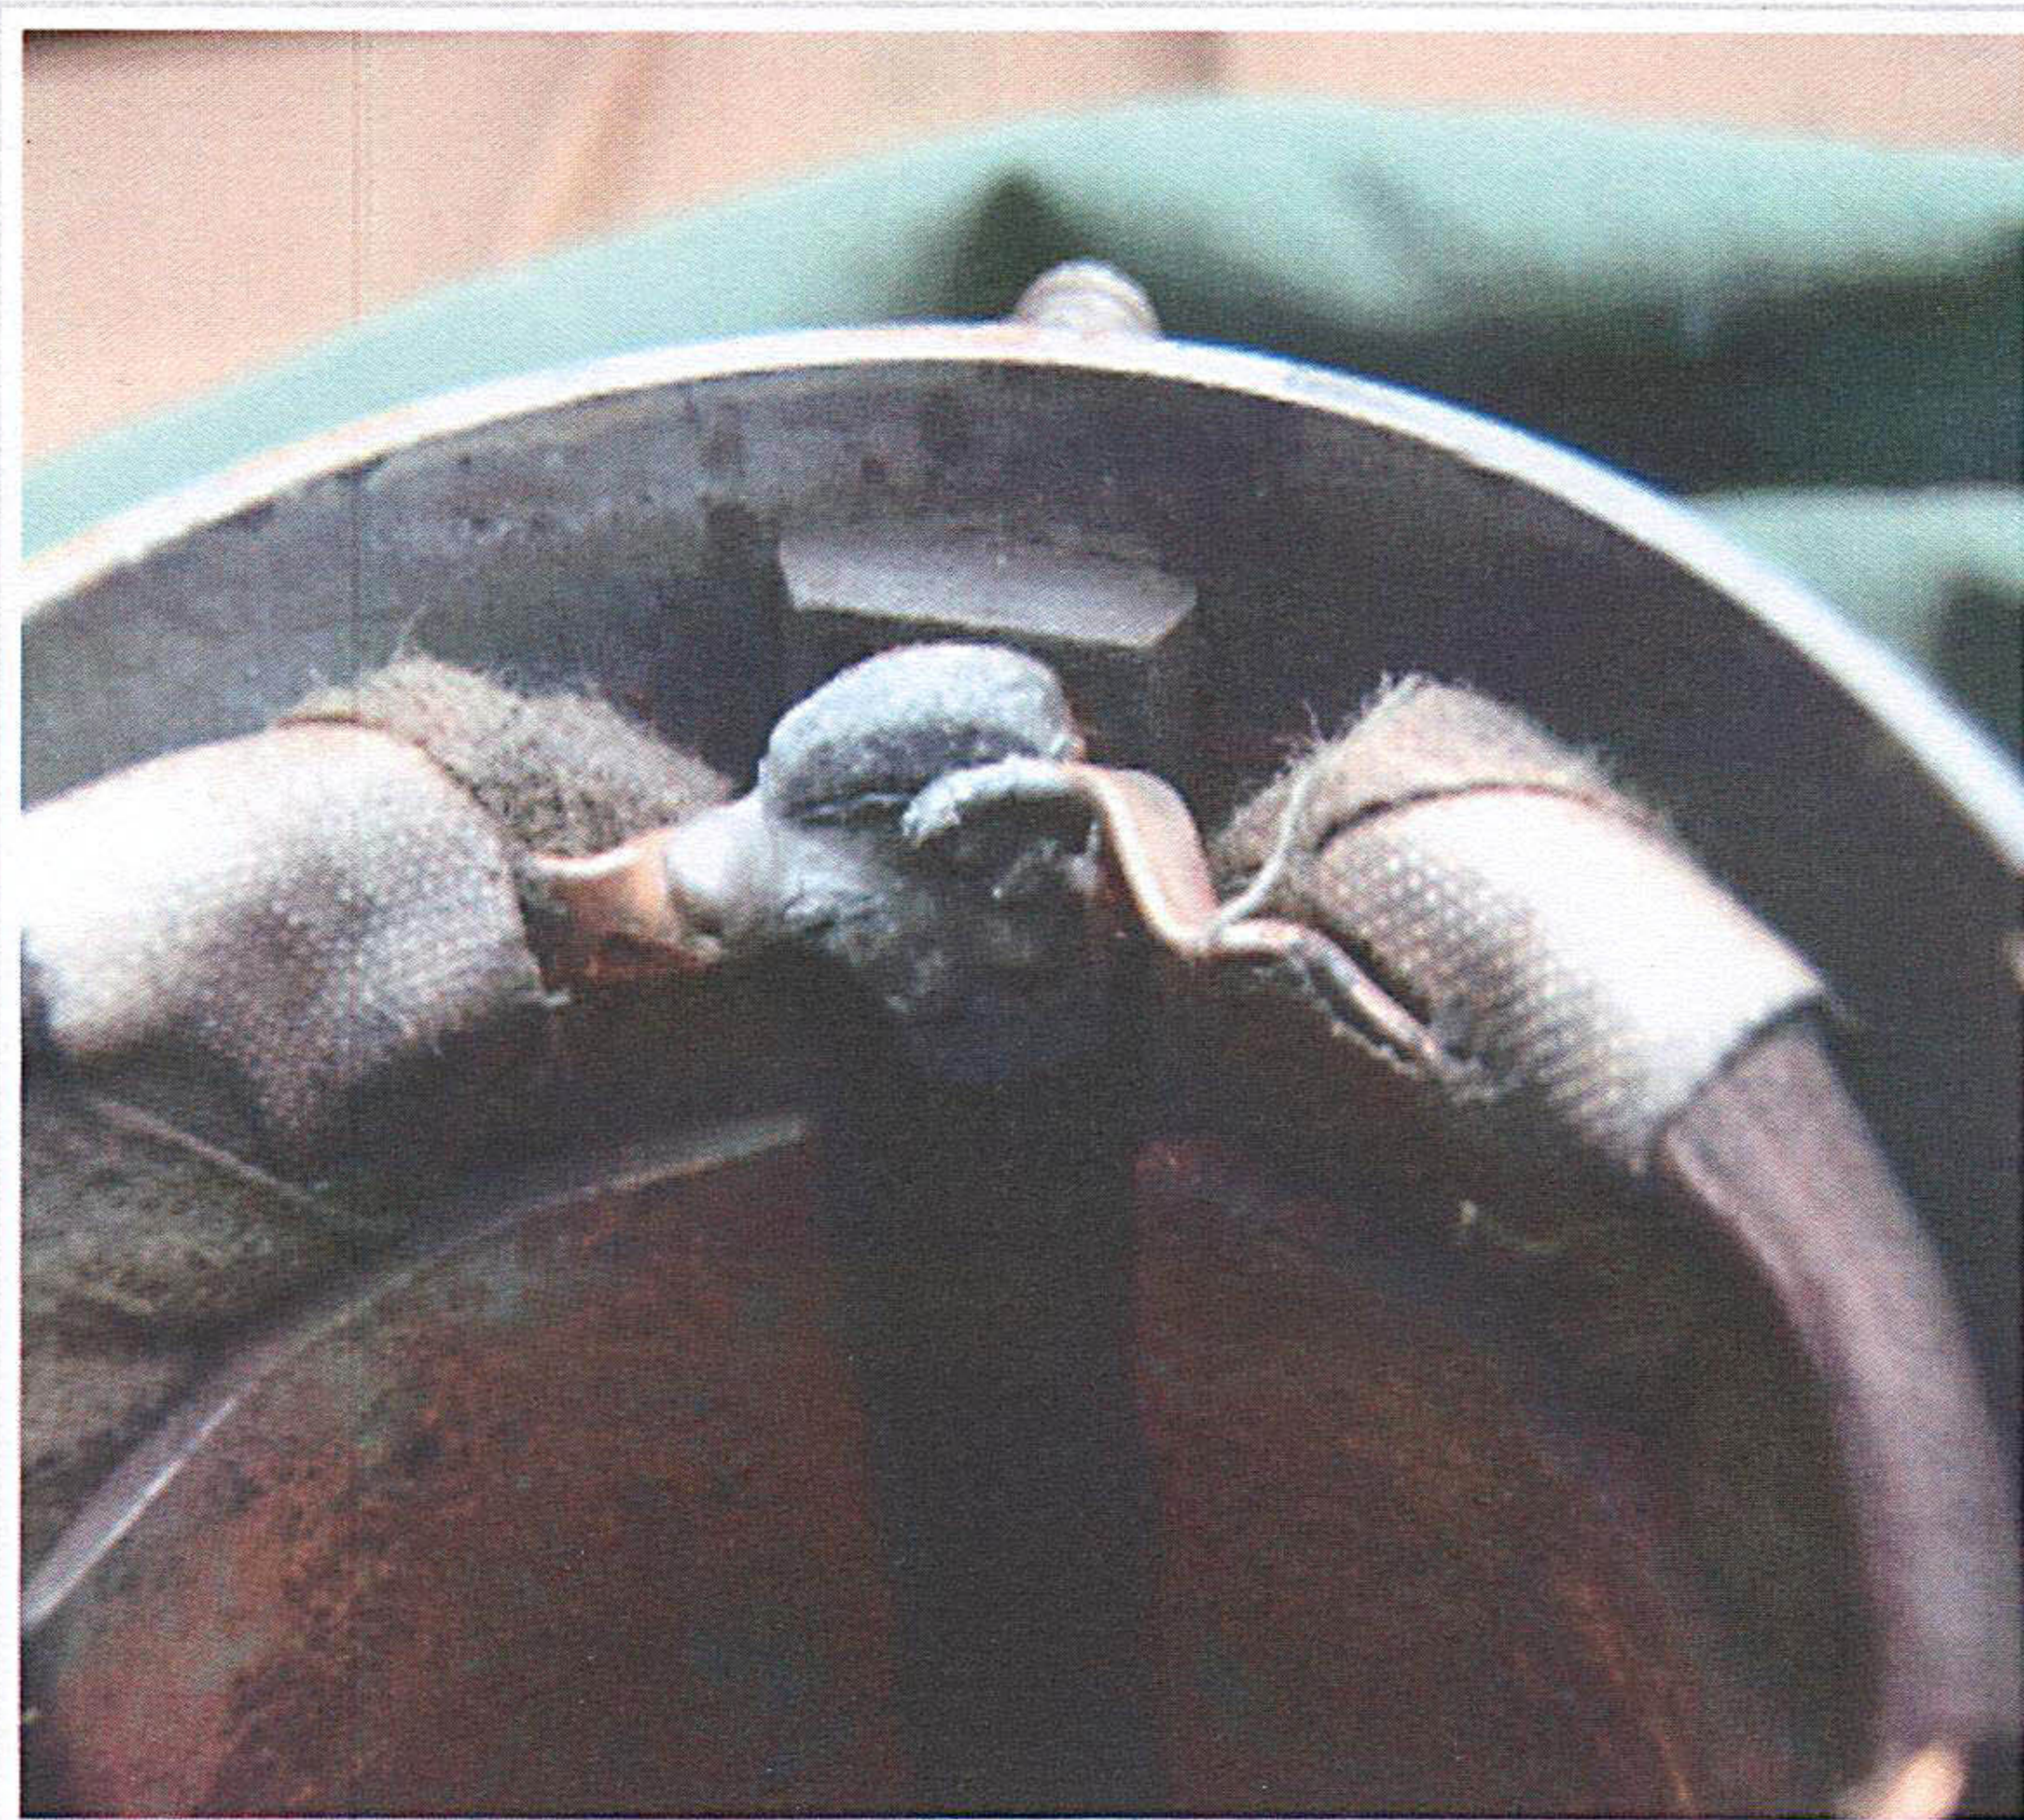
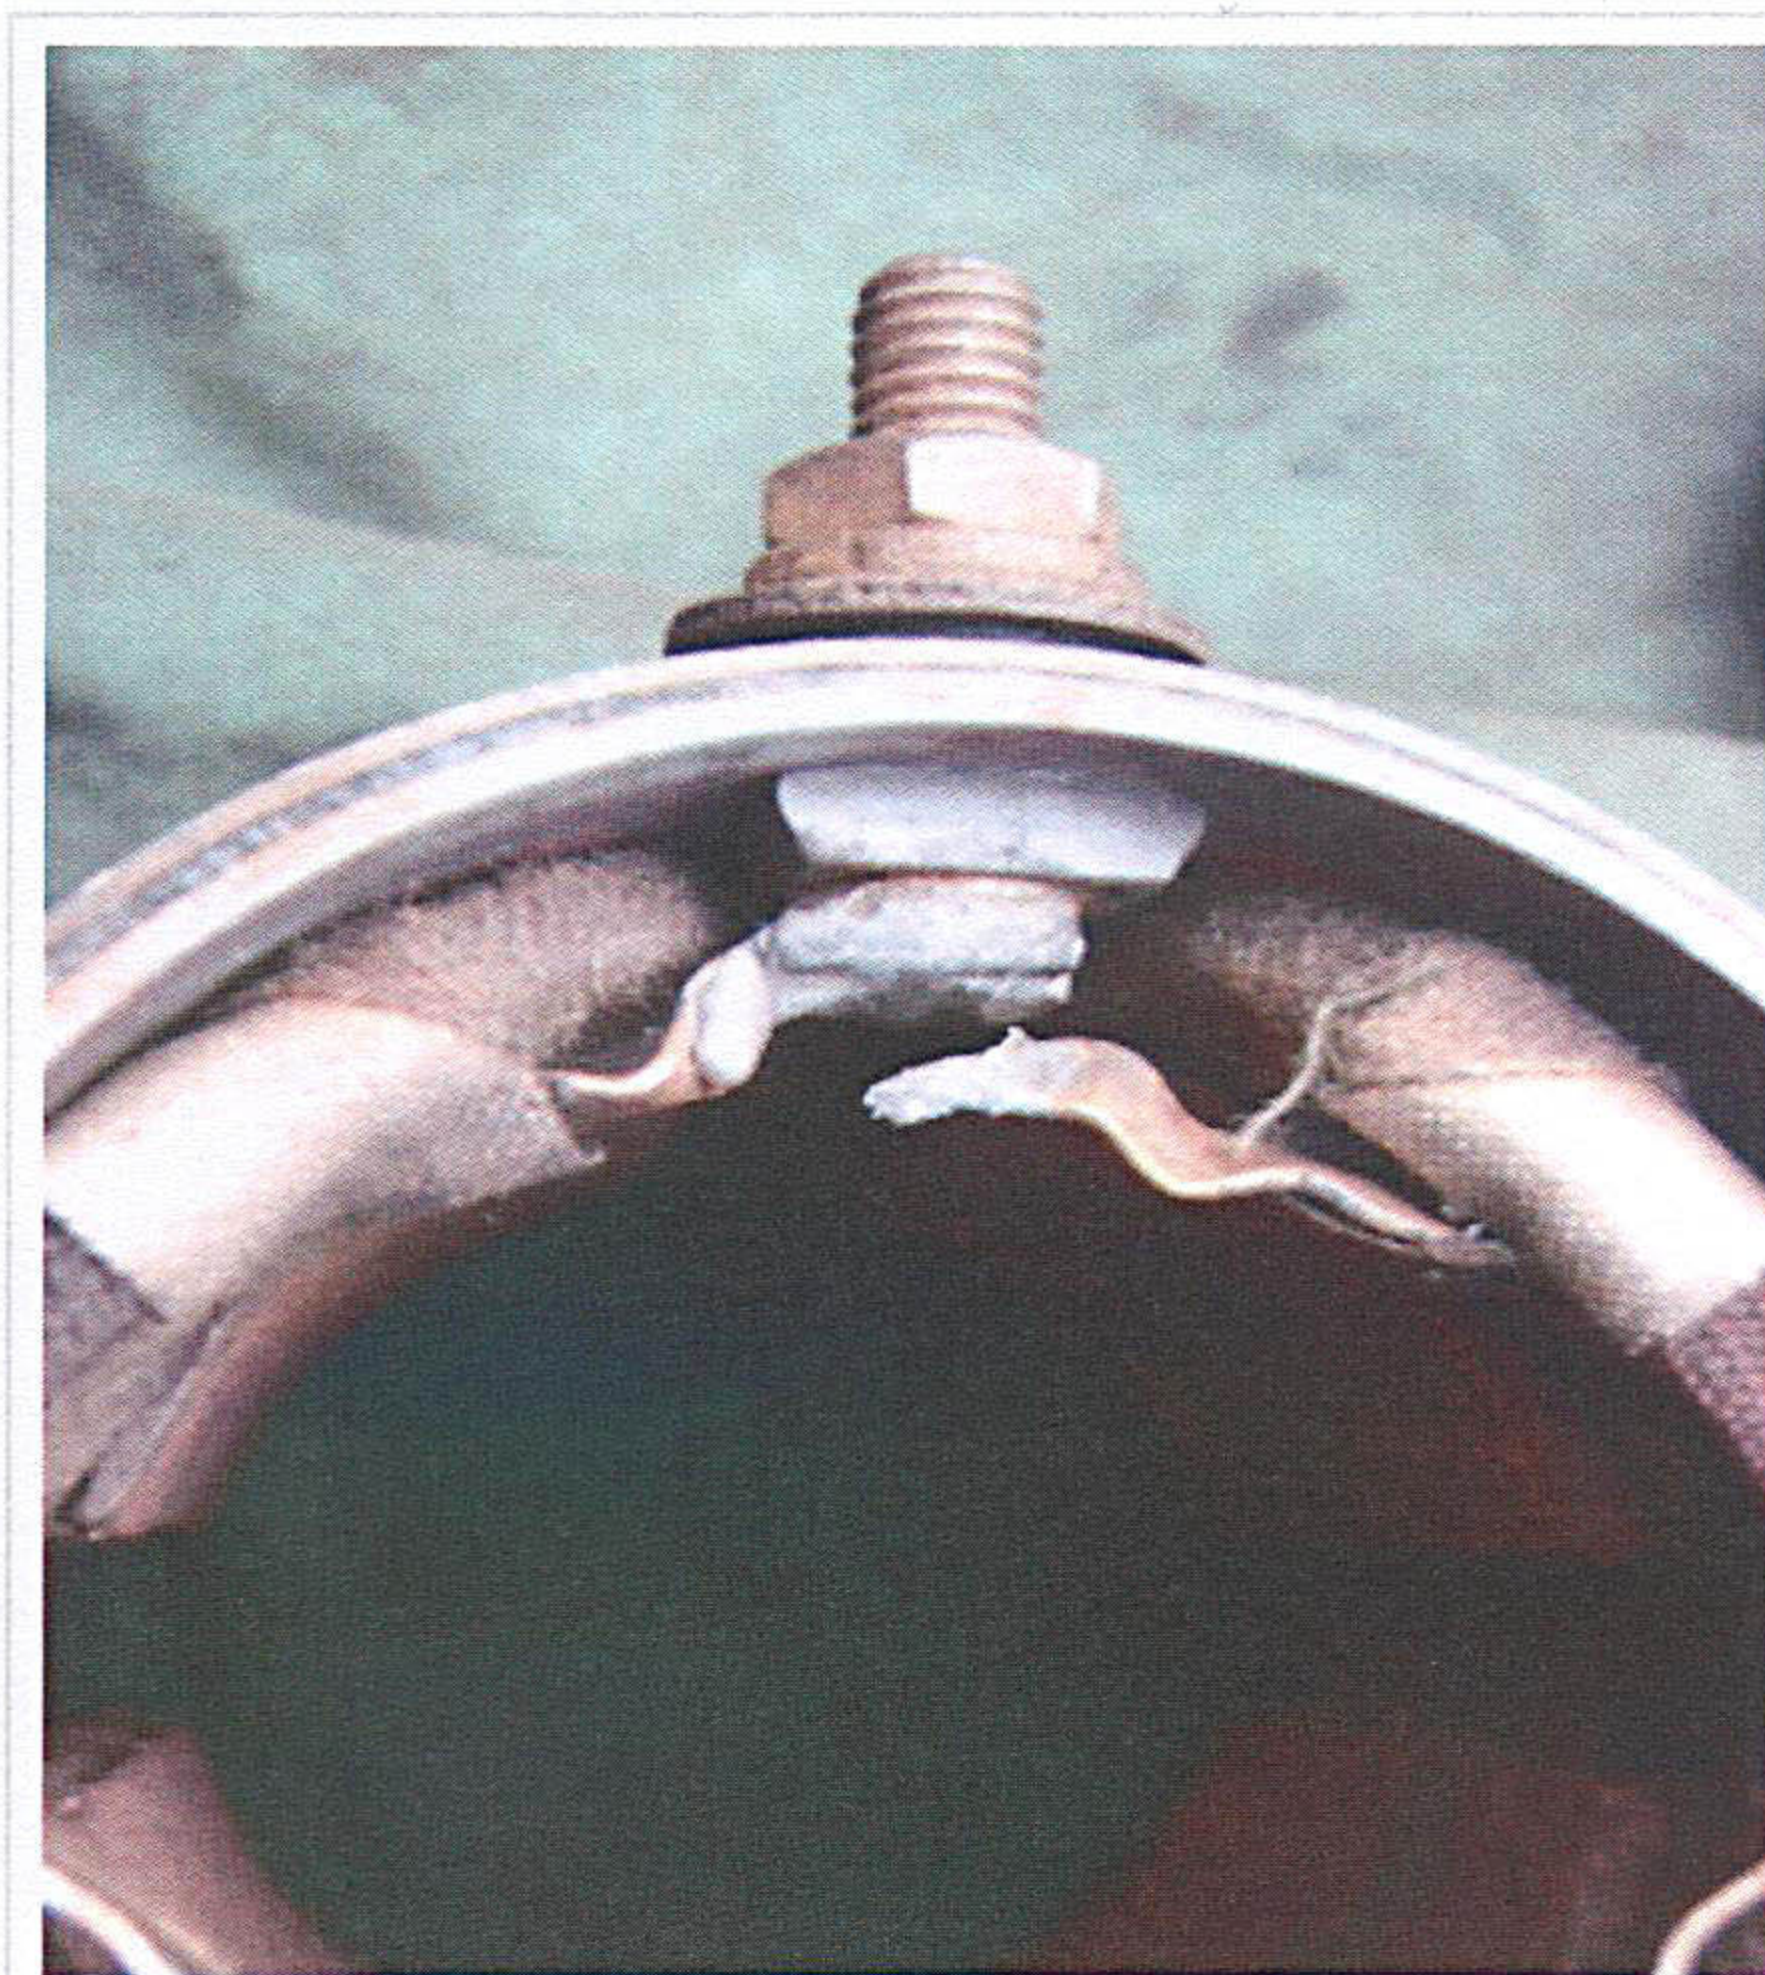
After taking the two end-caps off, removing the armature and brush holder/plate it all looked fairly typical in there; a bit rusty, a bit dirty, bearings a bit dry so i had a close inspection of the field windings. The main power lead connection from the starter solenoid bolts on to that 6mm threaded terminal on the top of the body, and theres two bus-bar type copper leads on the inside of the body which are connected to the adjacent field coils with a soldered join. It was the appearance of this soldered join which caught my attention; it looked like it had become hot enough at some time to semi-melt and had a dull grey `grainy` look about it. There was also tell-tale remains of solder on the inside of the motors body which looked like it had been either flung or blown there when in a molten state. After poking the join with a screwdriver one of the field coil wires became unattached. I don`t know whether it was only *just* connected or was detached and making contact but it was deffo a likely cause of this motors starting problem. The break could have been caused by either a dodgy power lead connection resulting in a high resistance heating up the terminal bolt/soldered join, prolonged cranking of the engine at some point, or doing the lead nut up without holding the second nut beneath the cable eyelet which could of twisted the terminal through the body and fracturing the joint.....or a combo of all three + 25 years wear and tear...

This is the dodgy connection. It looks like the terminal has spun around at some point and twisted the copper bus-bars possibly fracturing the solder. The bus-bar to the coil wasn`t hanging off like this after dissassembly, only after i`d poked it about with a screwdriver, but shows how fragile the connection was;

To repair it just meant re-soldering the join but i knew i would have trouble in getting enough heat into that terminal - theres quite a lot of material in the bolt and copper bus-bars which would suck the heat out of any soldering iron i used. A normal electronics soldering iron would have nowhere near enough power so i tried my 100W soldering gun. Even that didn't impart enough heat into the metal to get it hot enough for a good, solid join - the solder just forming blobs which sat on top of the original, so i had to improvise a high-heat soldering device!

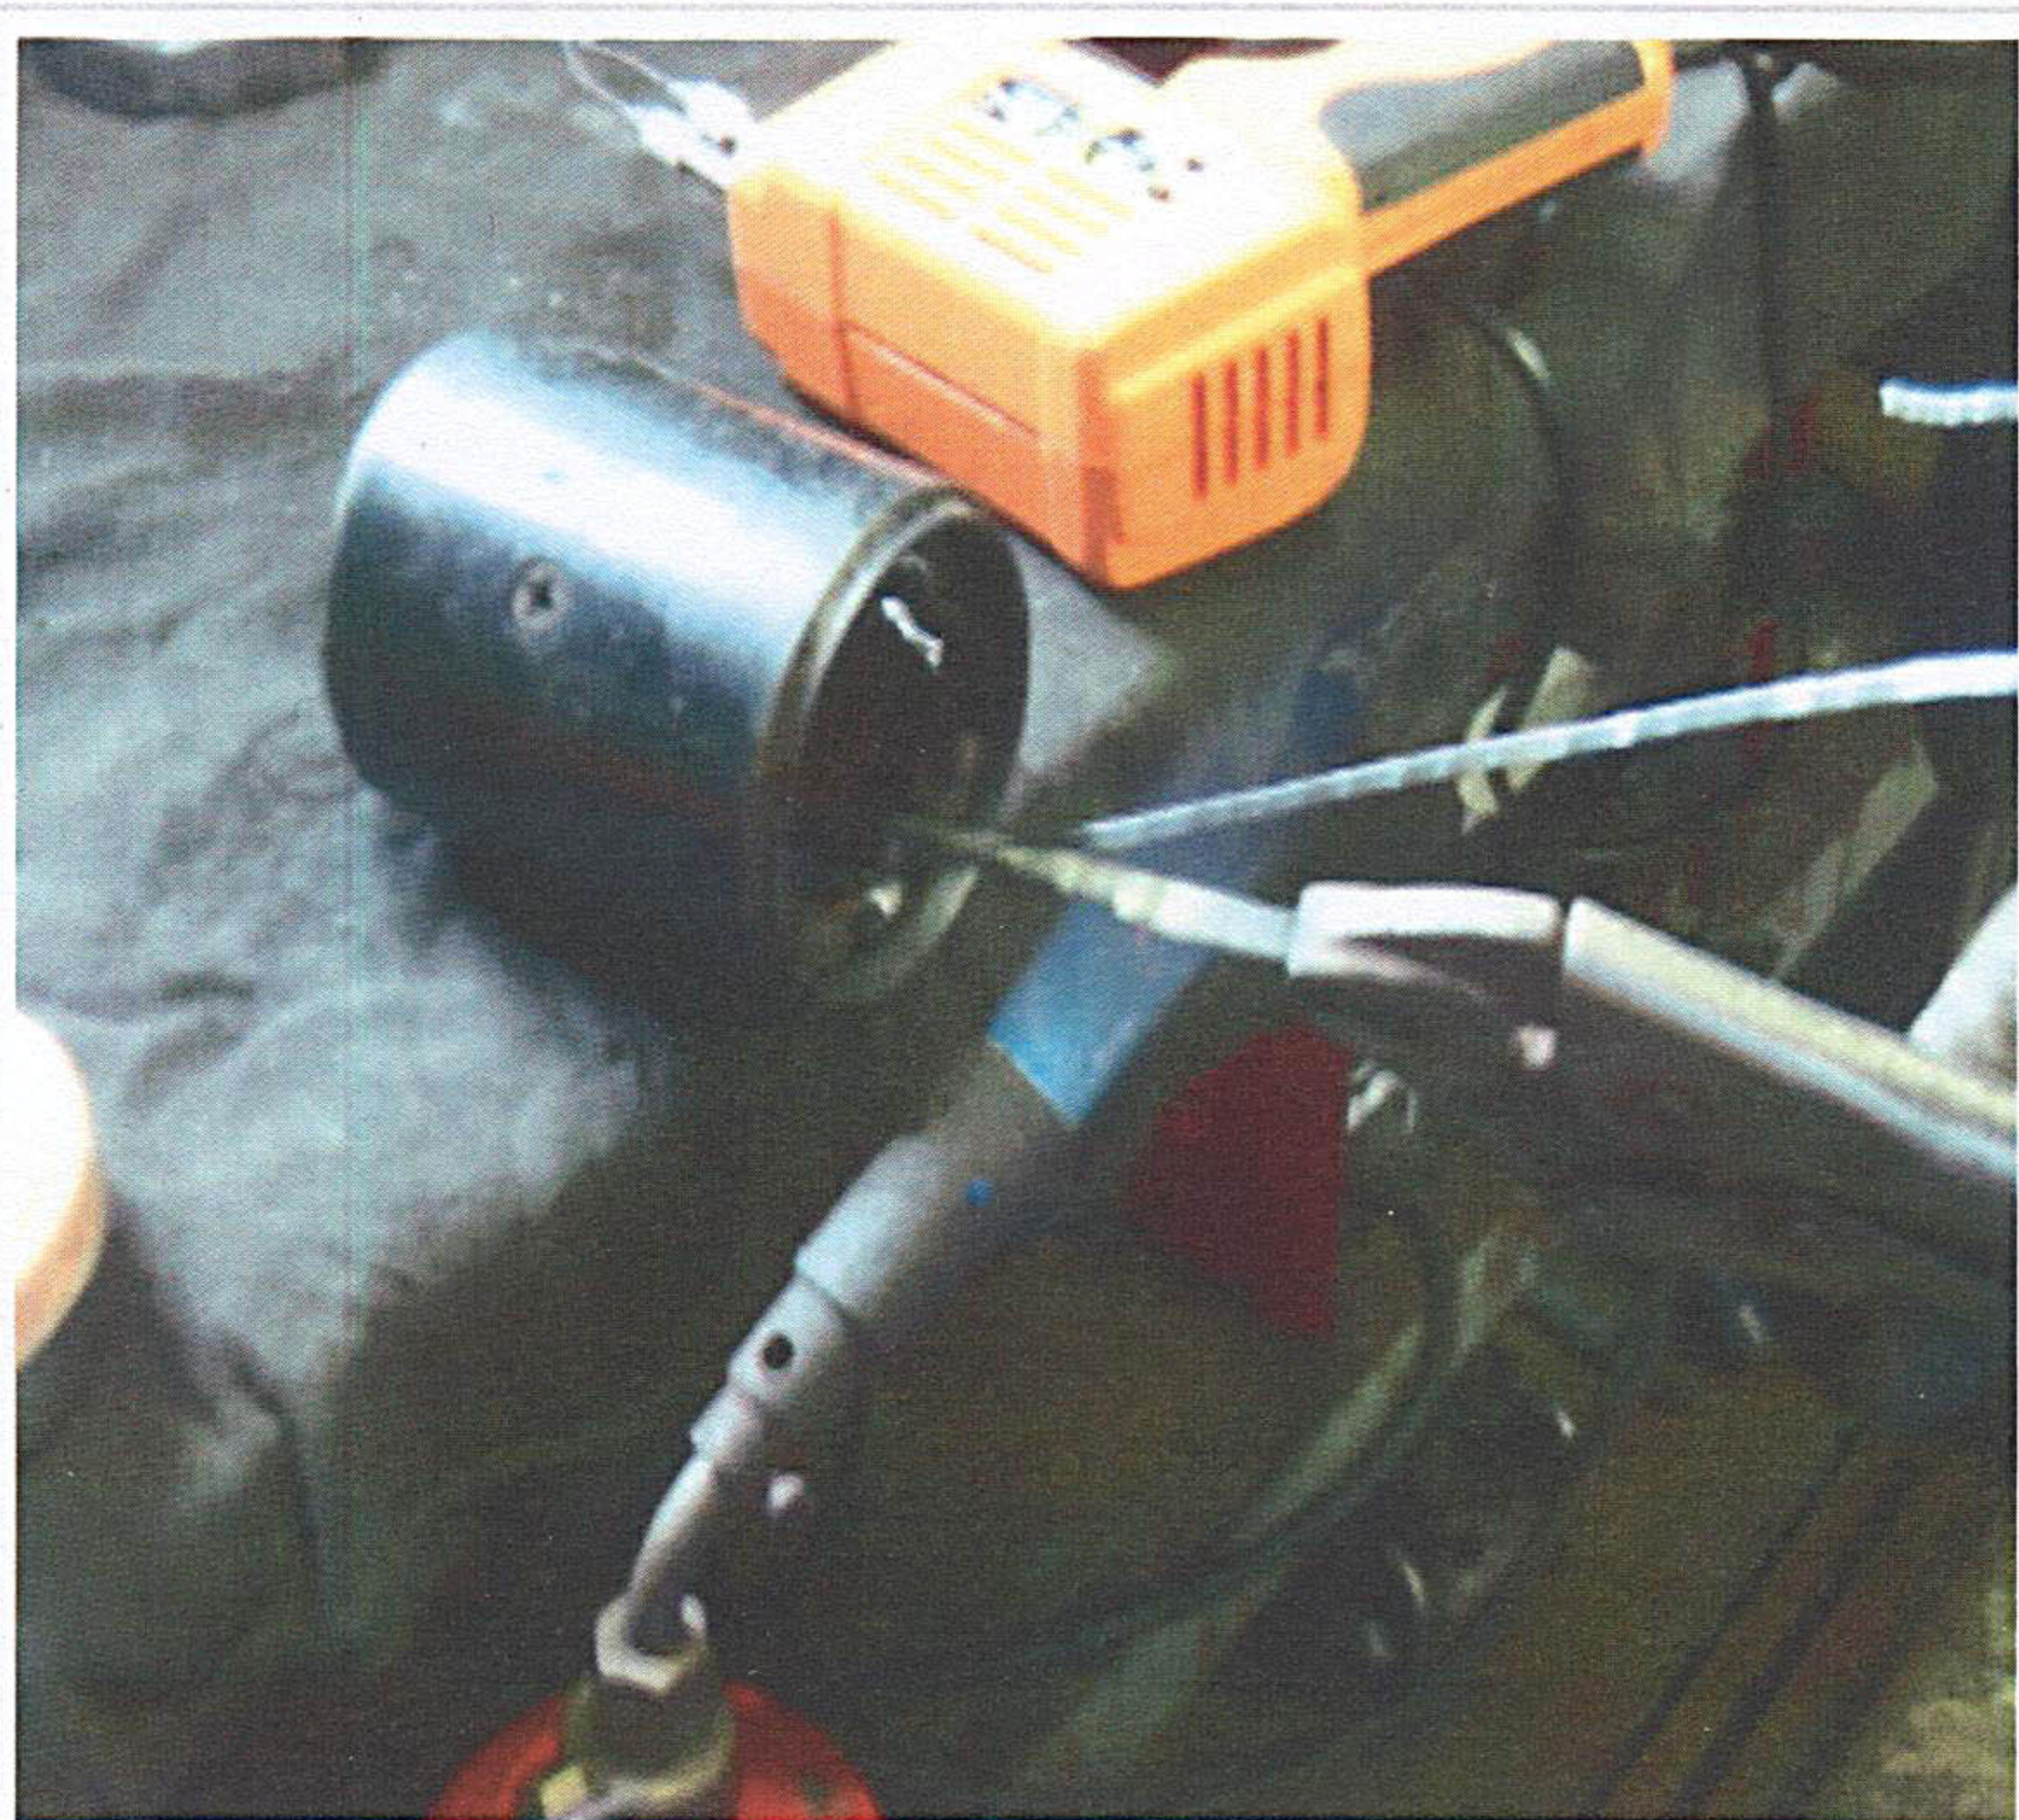
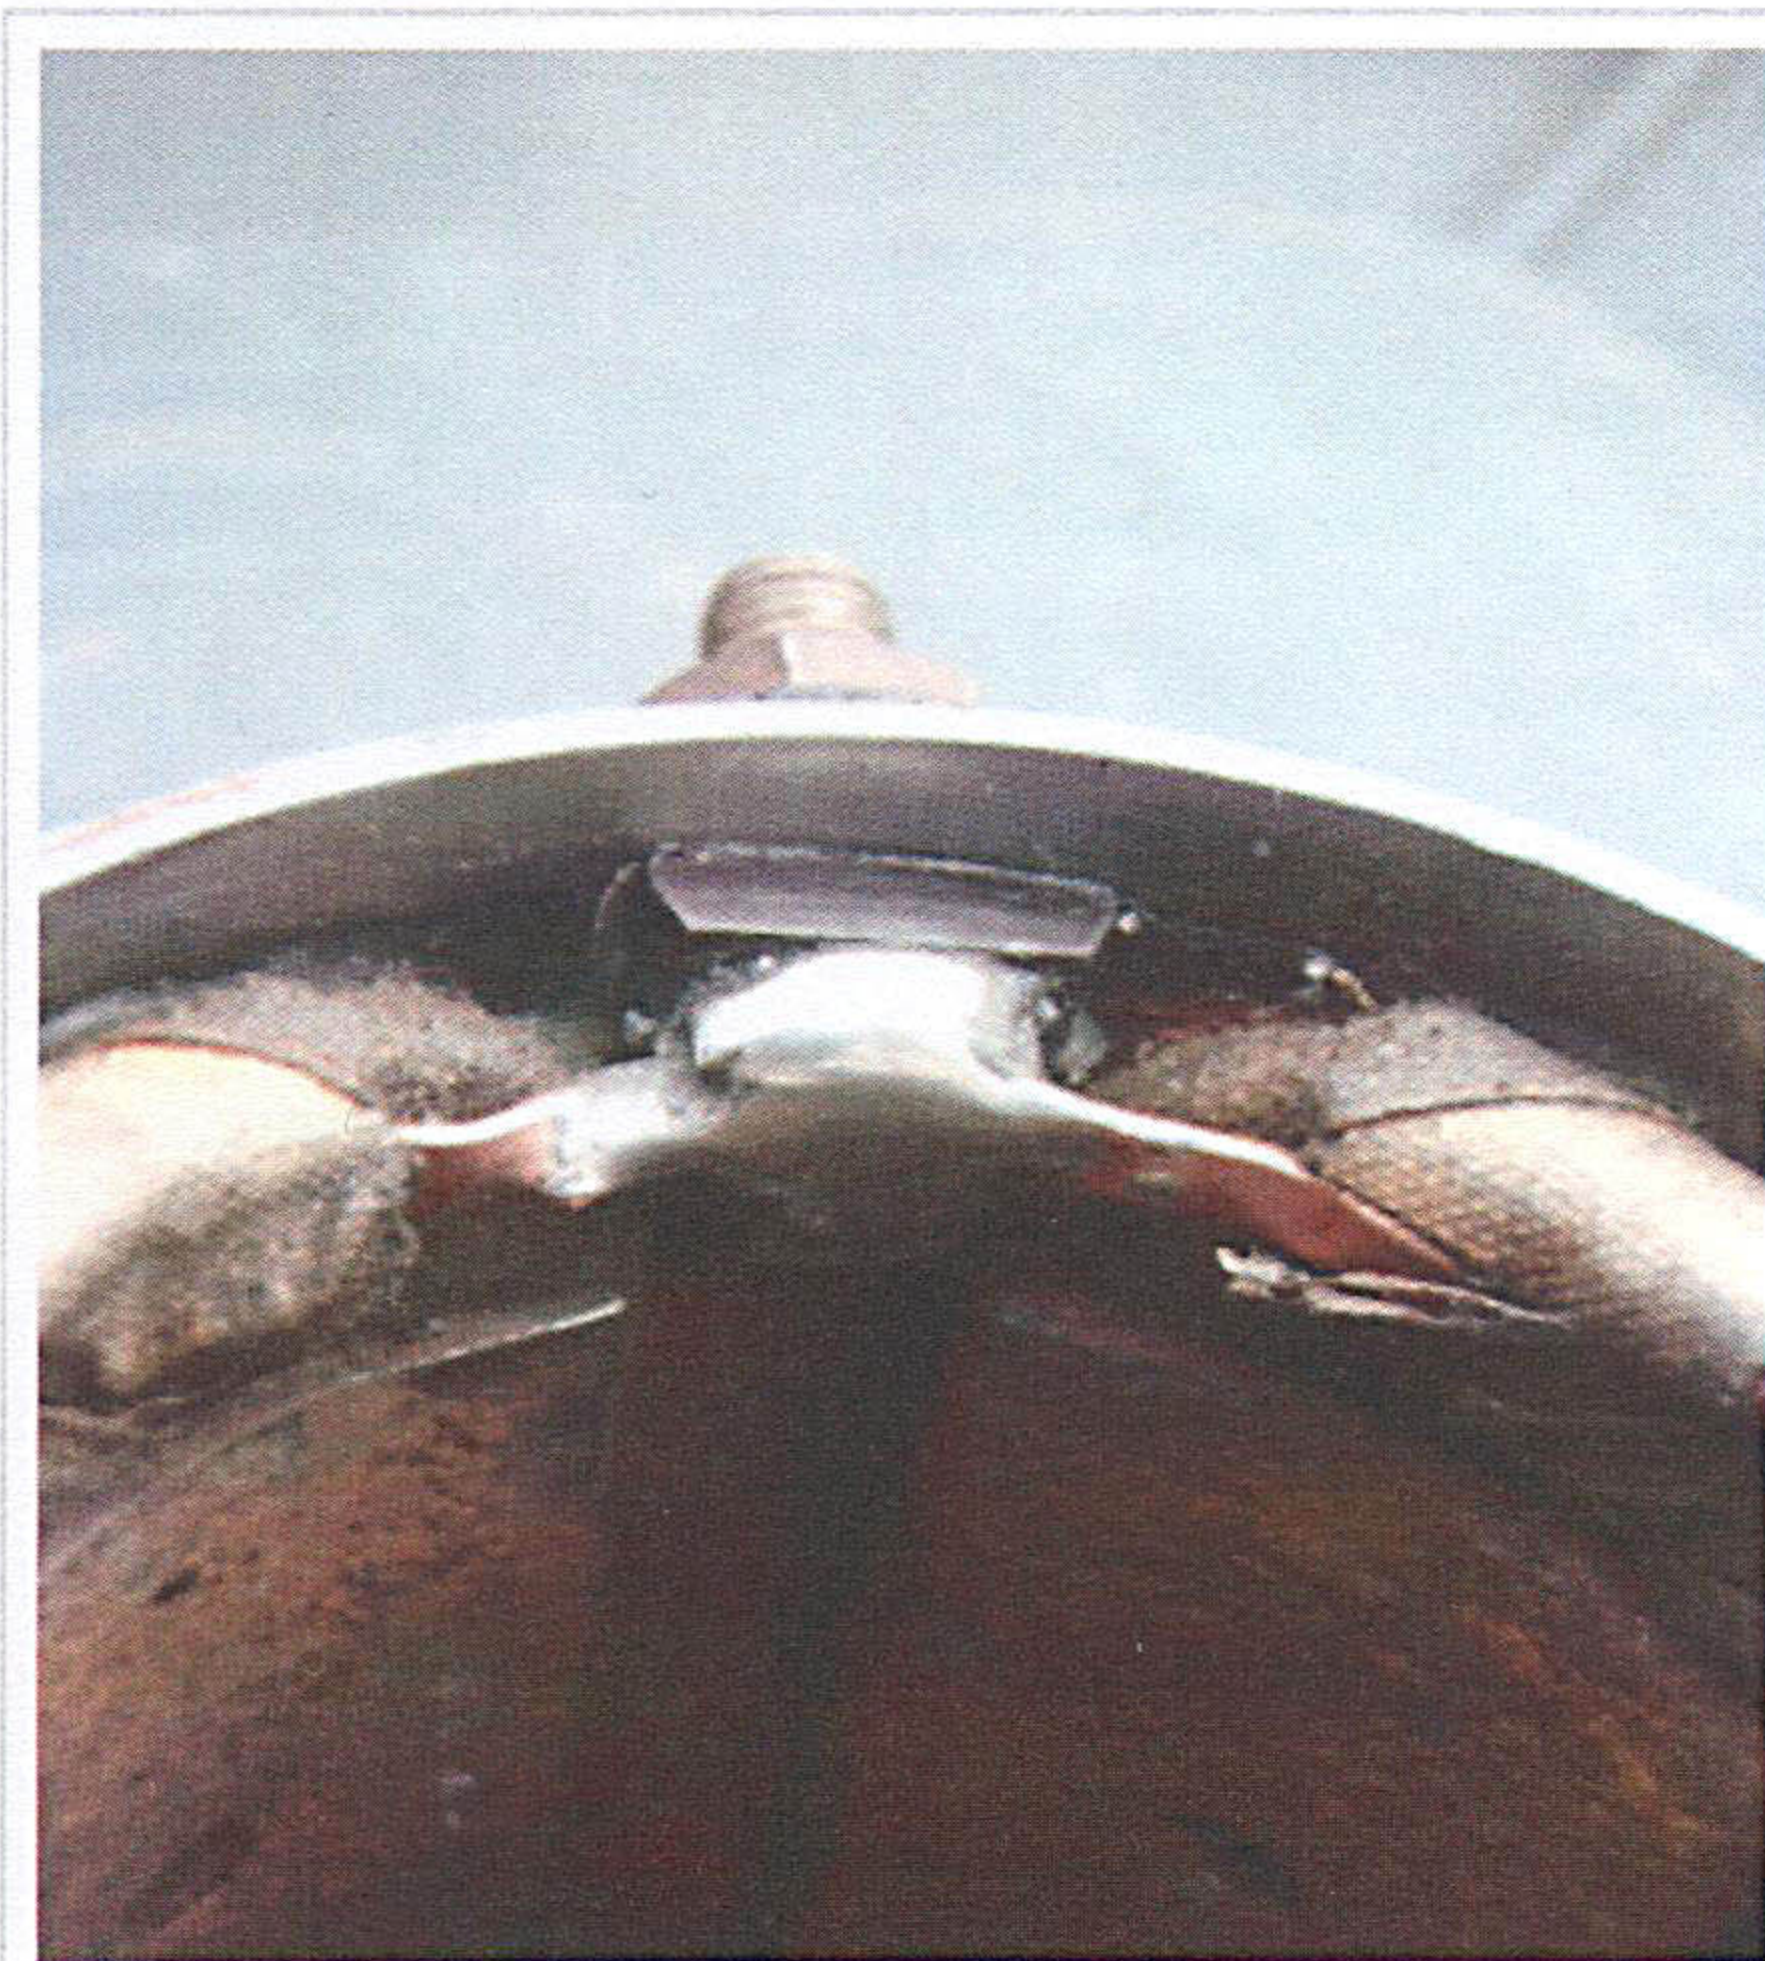
The improvised soldering iron and finished join;

I used a hefty square-section floorboard nail in conjunction with my trusty gas torch. By holding the nail with some grips and heating up the nail in the middle to red-hot the end was hot enough to rest onto the starter motor terminal and complete the join, I really needed three hands or an assistant though - i had to hold the length of solder in my teeth and dab it onto the join while holding the pliers in one hand and the gas torch in the other!

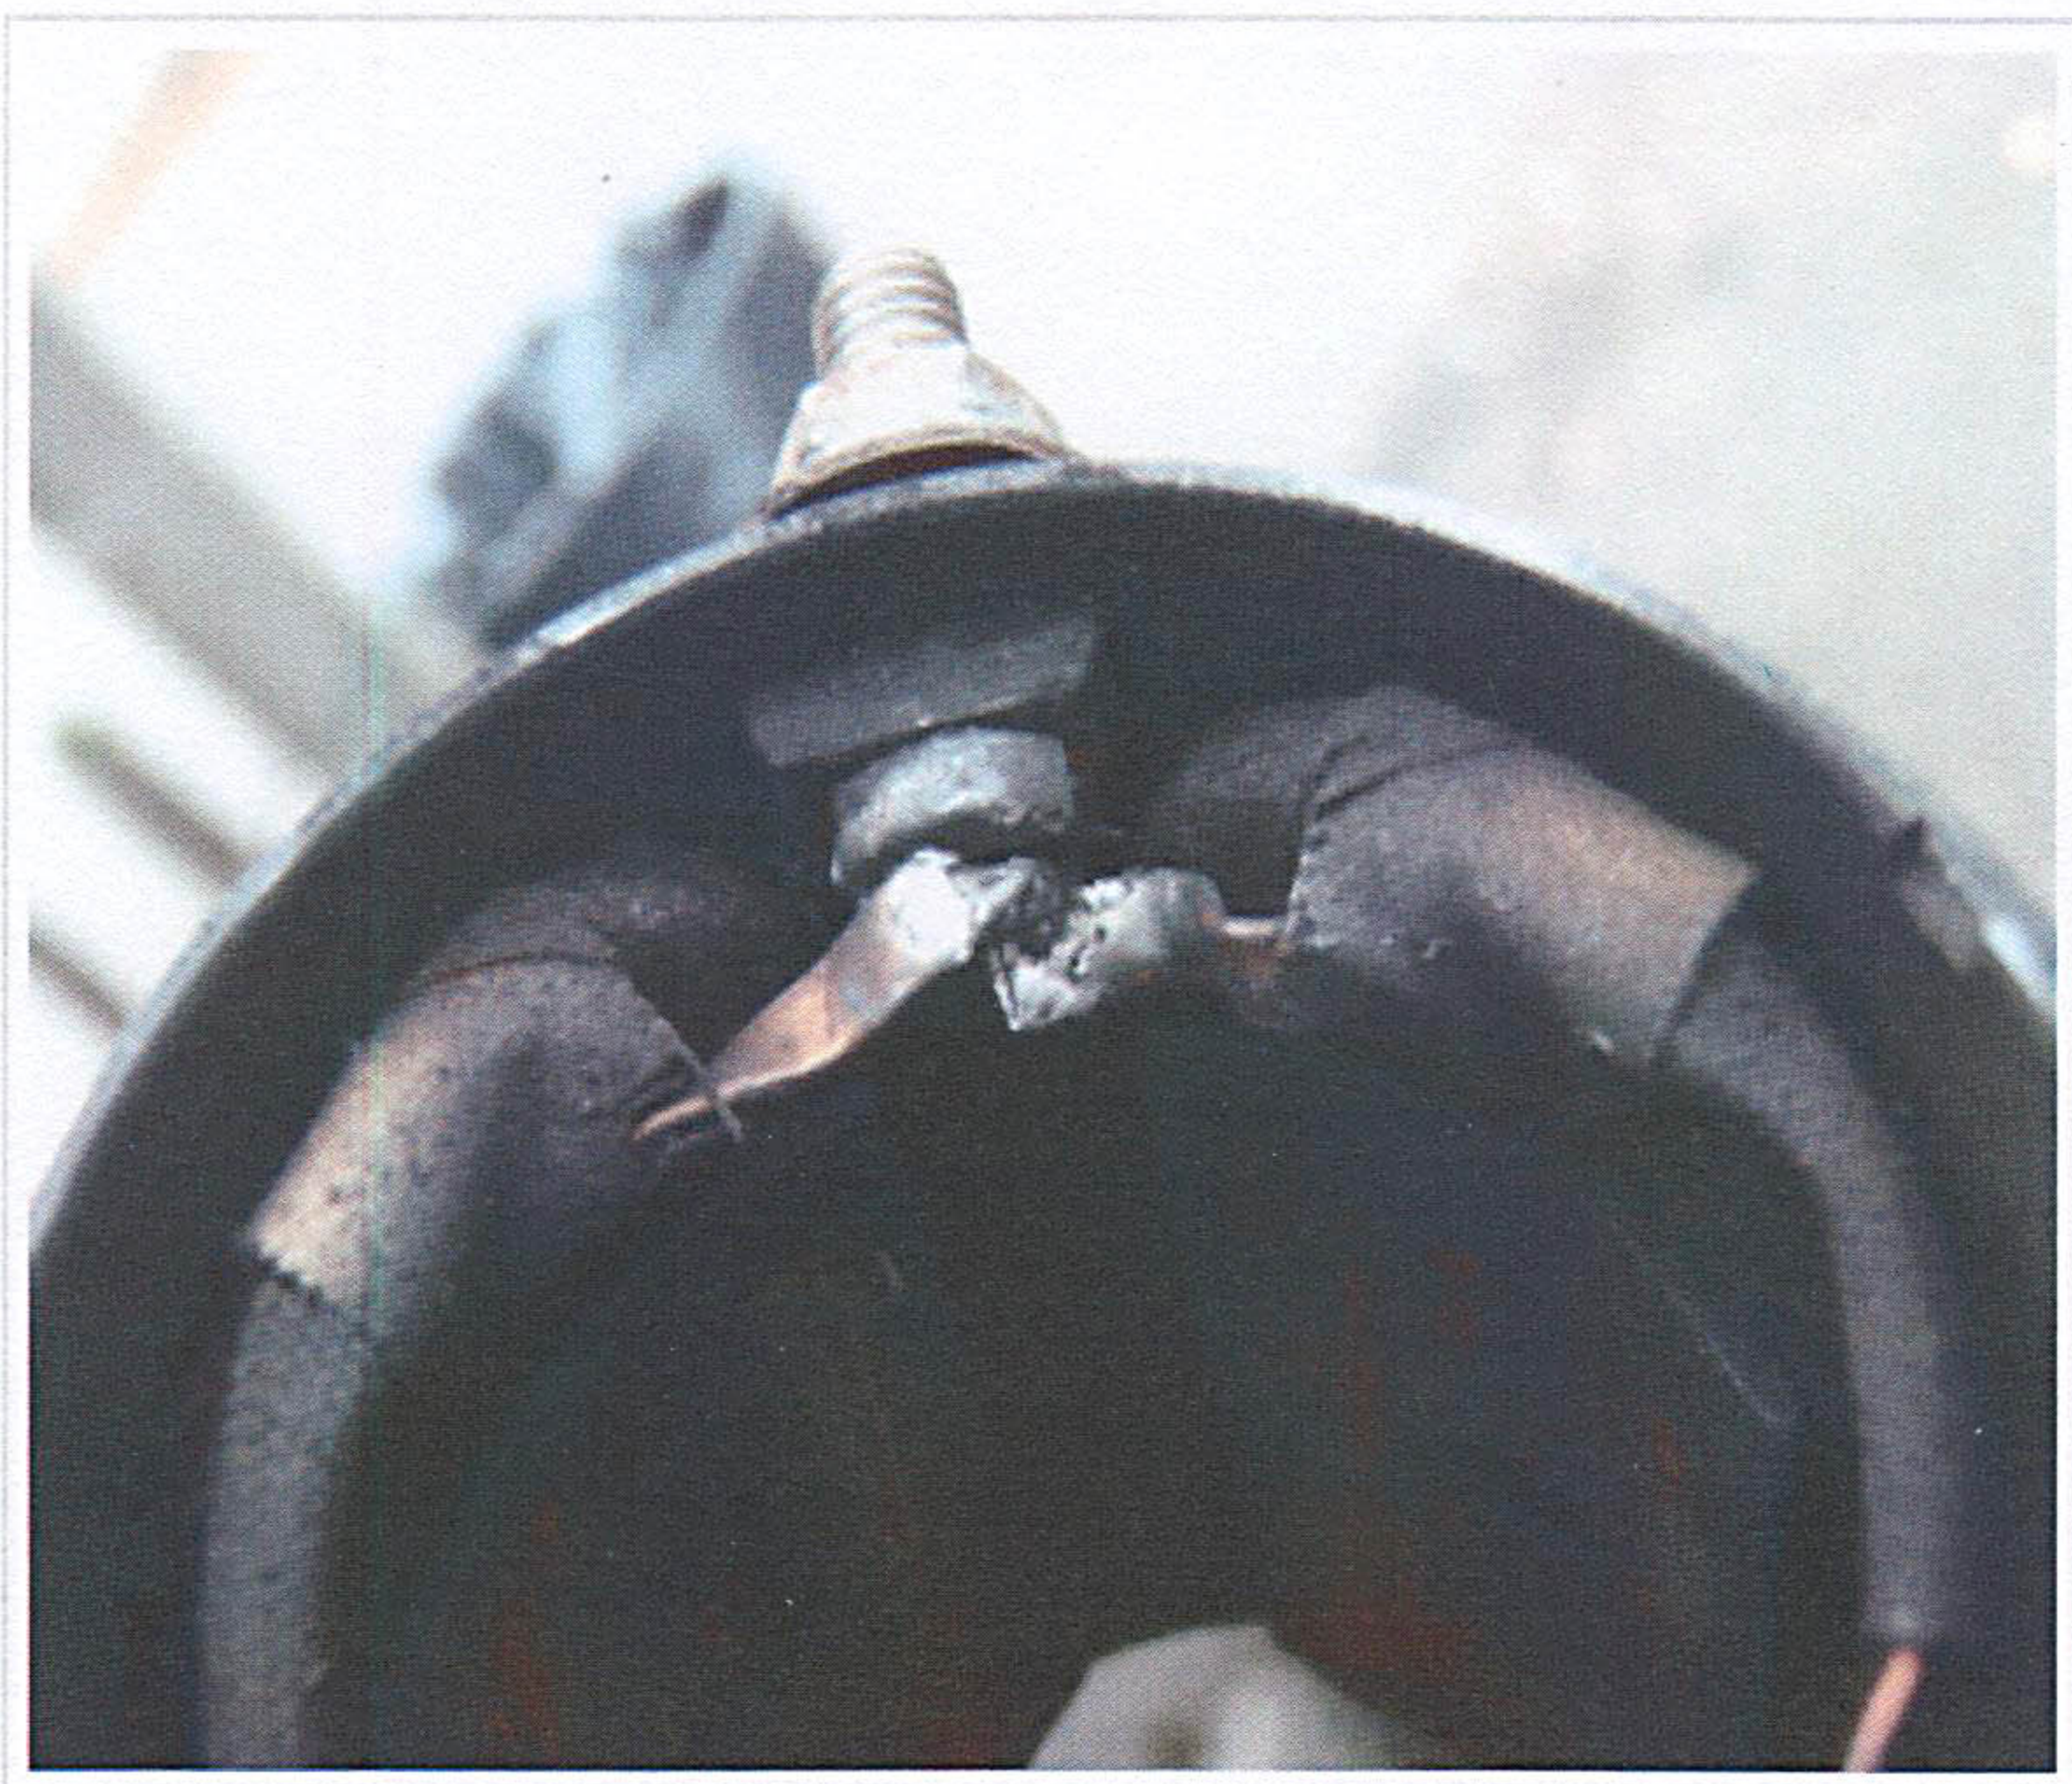
On stripping down another CX starter motor i found the main power terminal to be loose and twist when the nut was being undone. Realising the damage that can occur when this happens i was careful to hold the post as still as possible while undoing the 10mm nut. When the end cap was removed and the brush base plate removed i found this!:

This damage was definately caused by the terminal post twisting as the power lead eyelet was being connected/disconnected. Amazingly, the starter was still working OK in this condition, but not to it`s full potential. This motor needed both re-soldering and the earth strap mod (see below) to resore it to full efficiency.

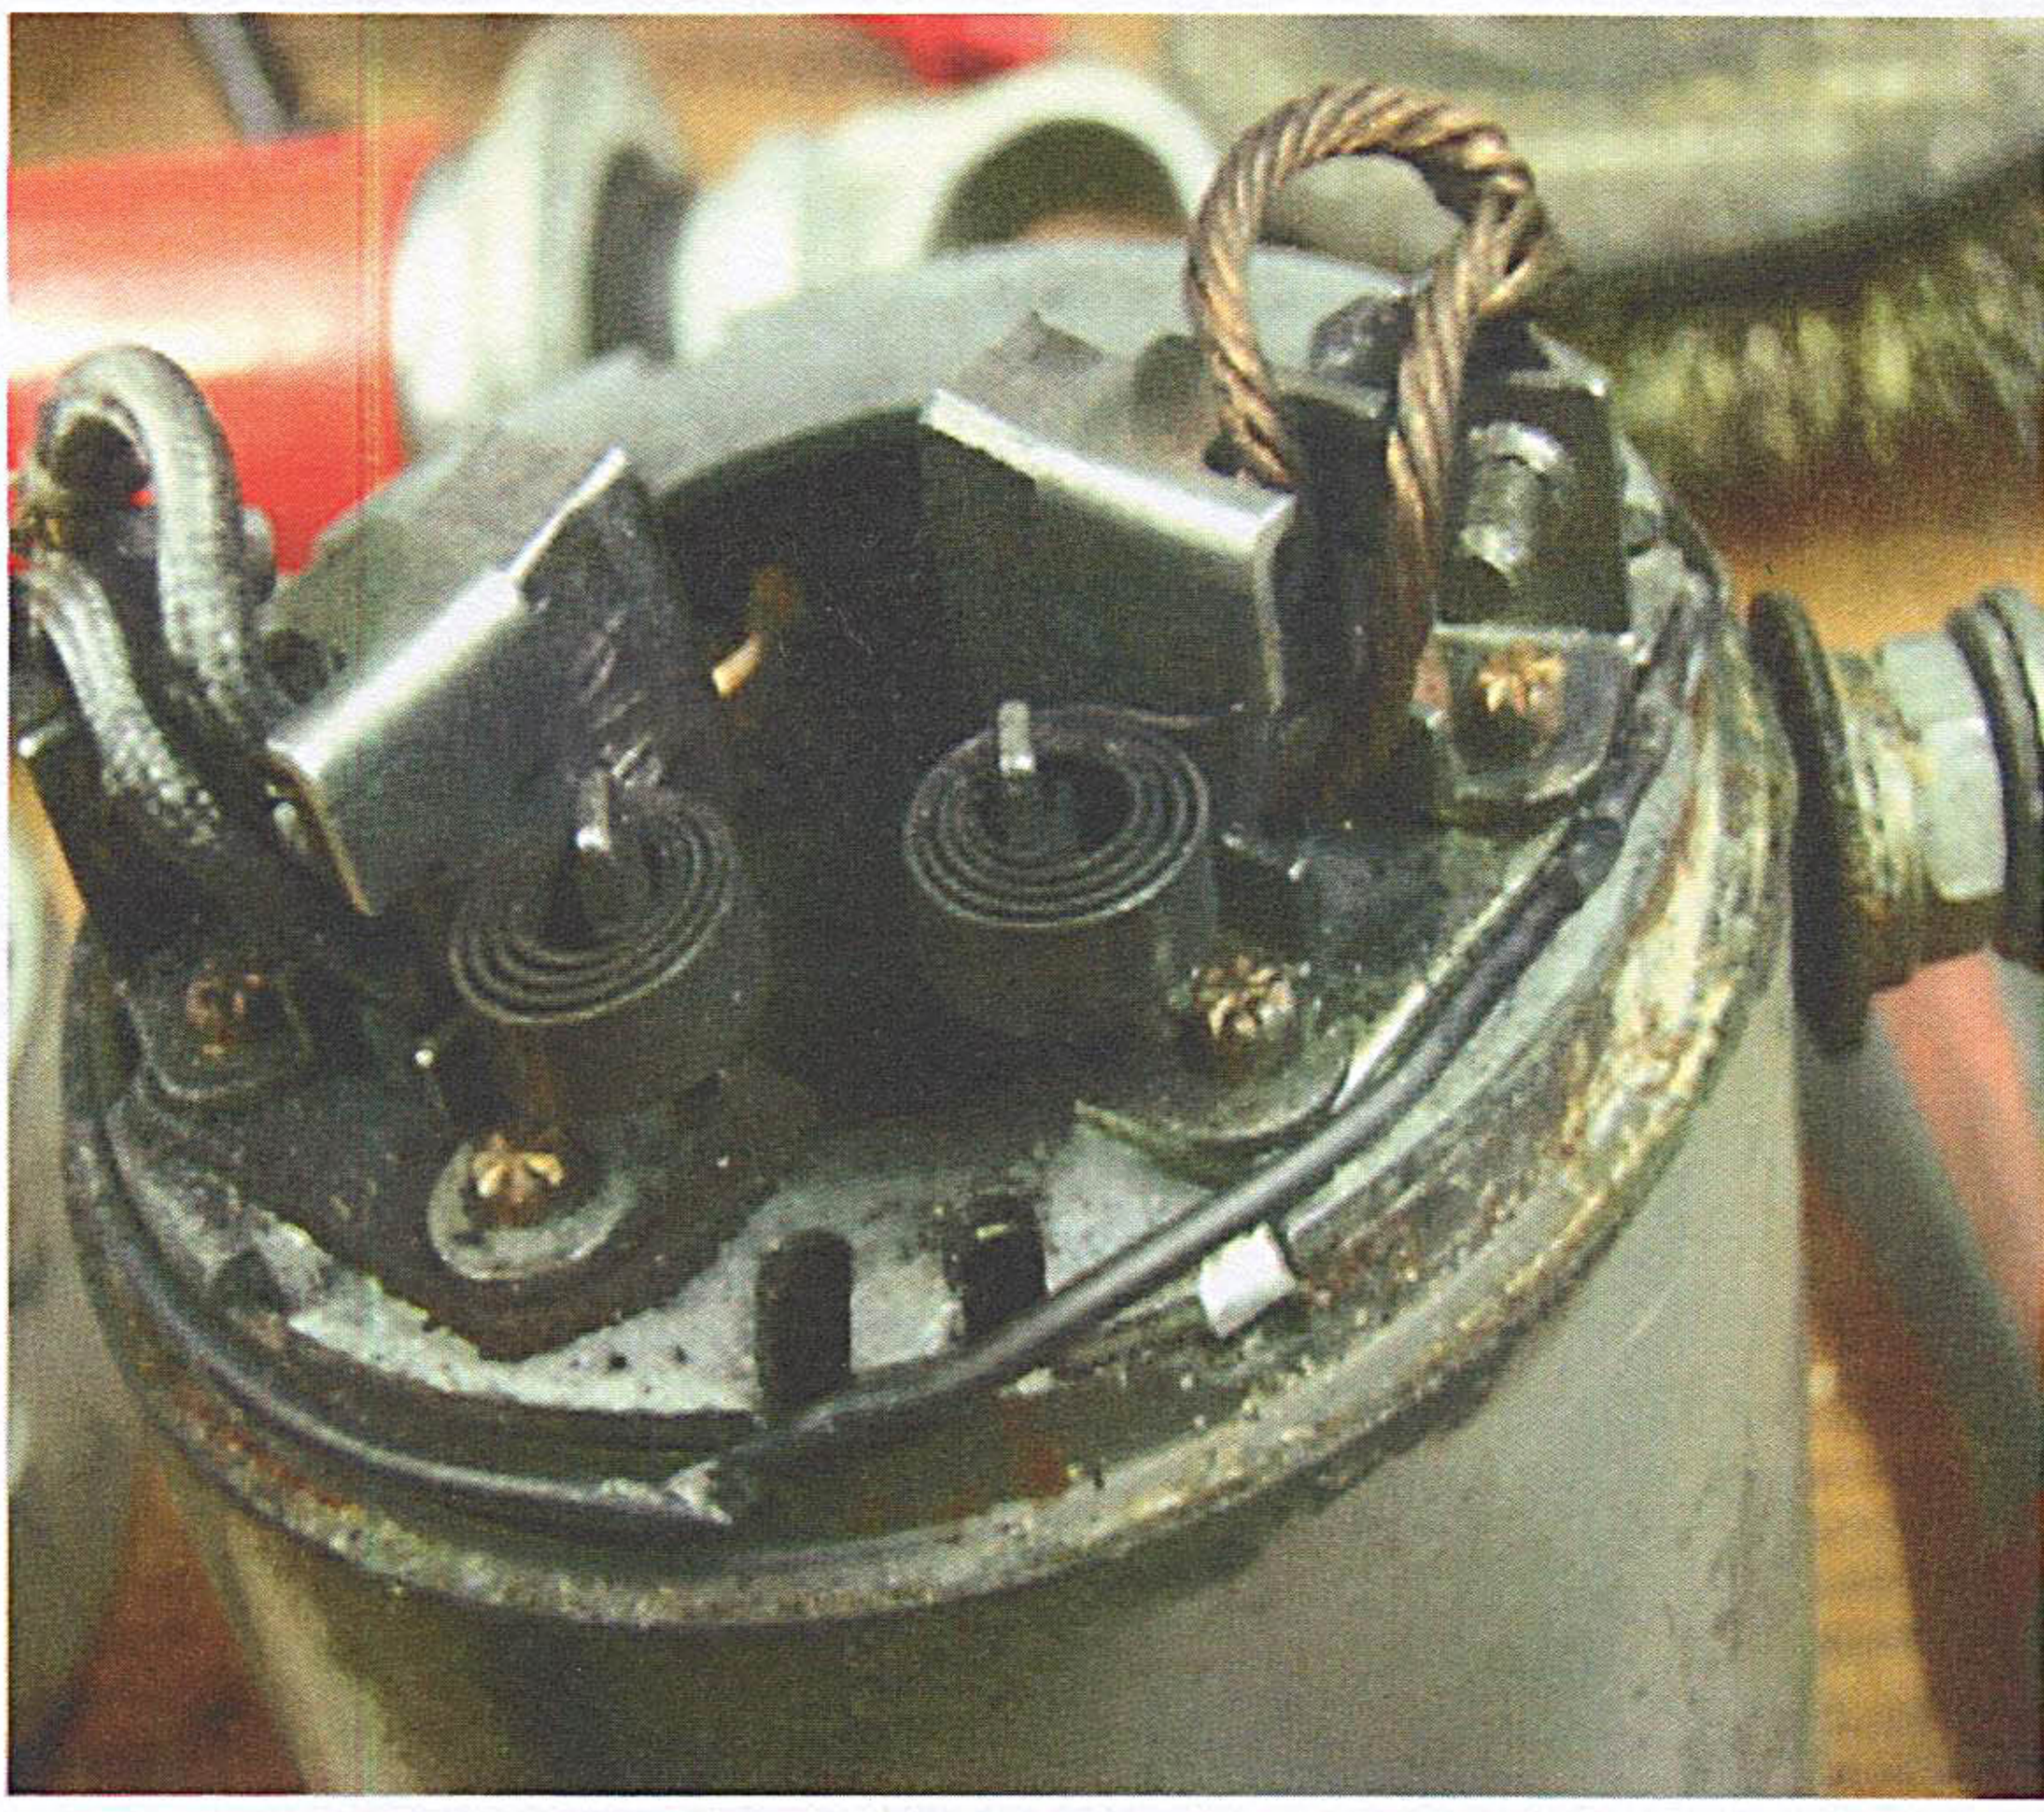
Anyway, after removing the starter motor from the engine and taking off the end cap the first thing i see is the displaced o-ring. I don't know whether it was like that from new or not but the water and gunge that could of found it's way inside probably didn't help the reliability of the electrics.
