## OFAPARS` V TWINS.

### **Lethargic starter motor.**

### 650 starter motor.

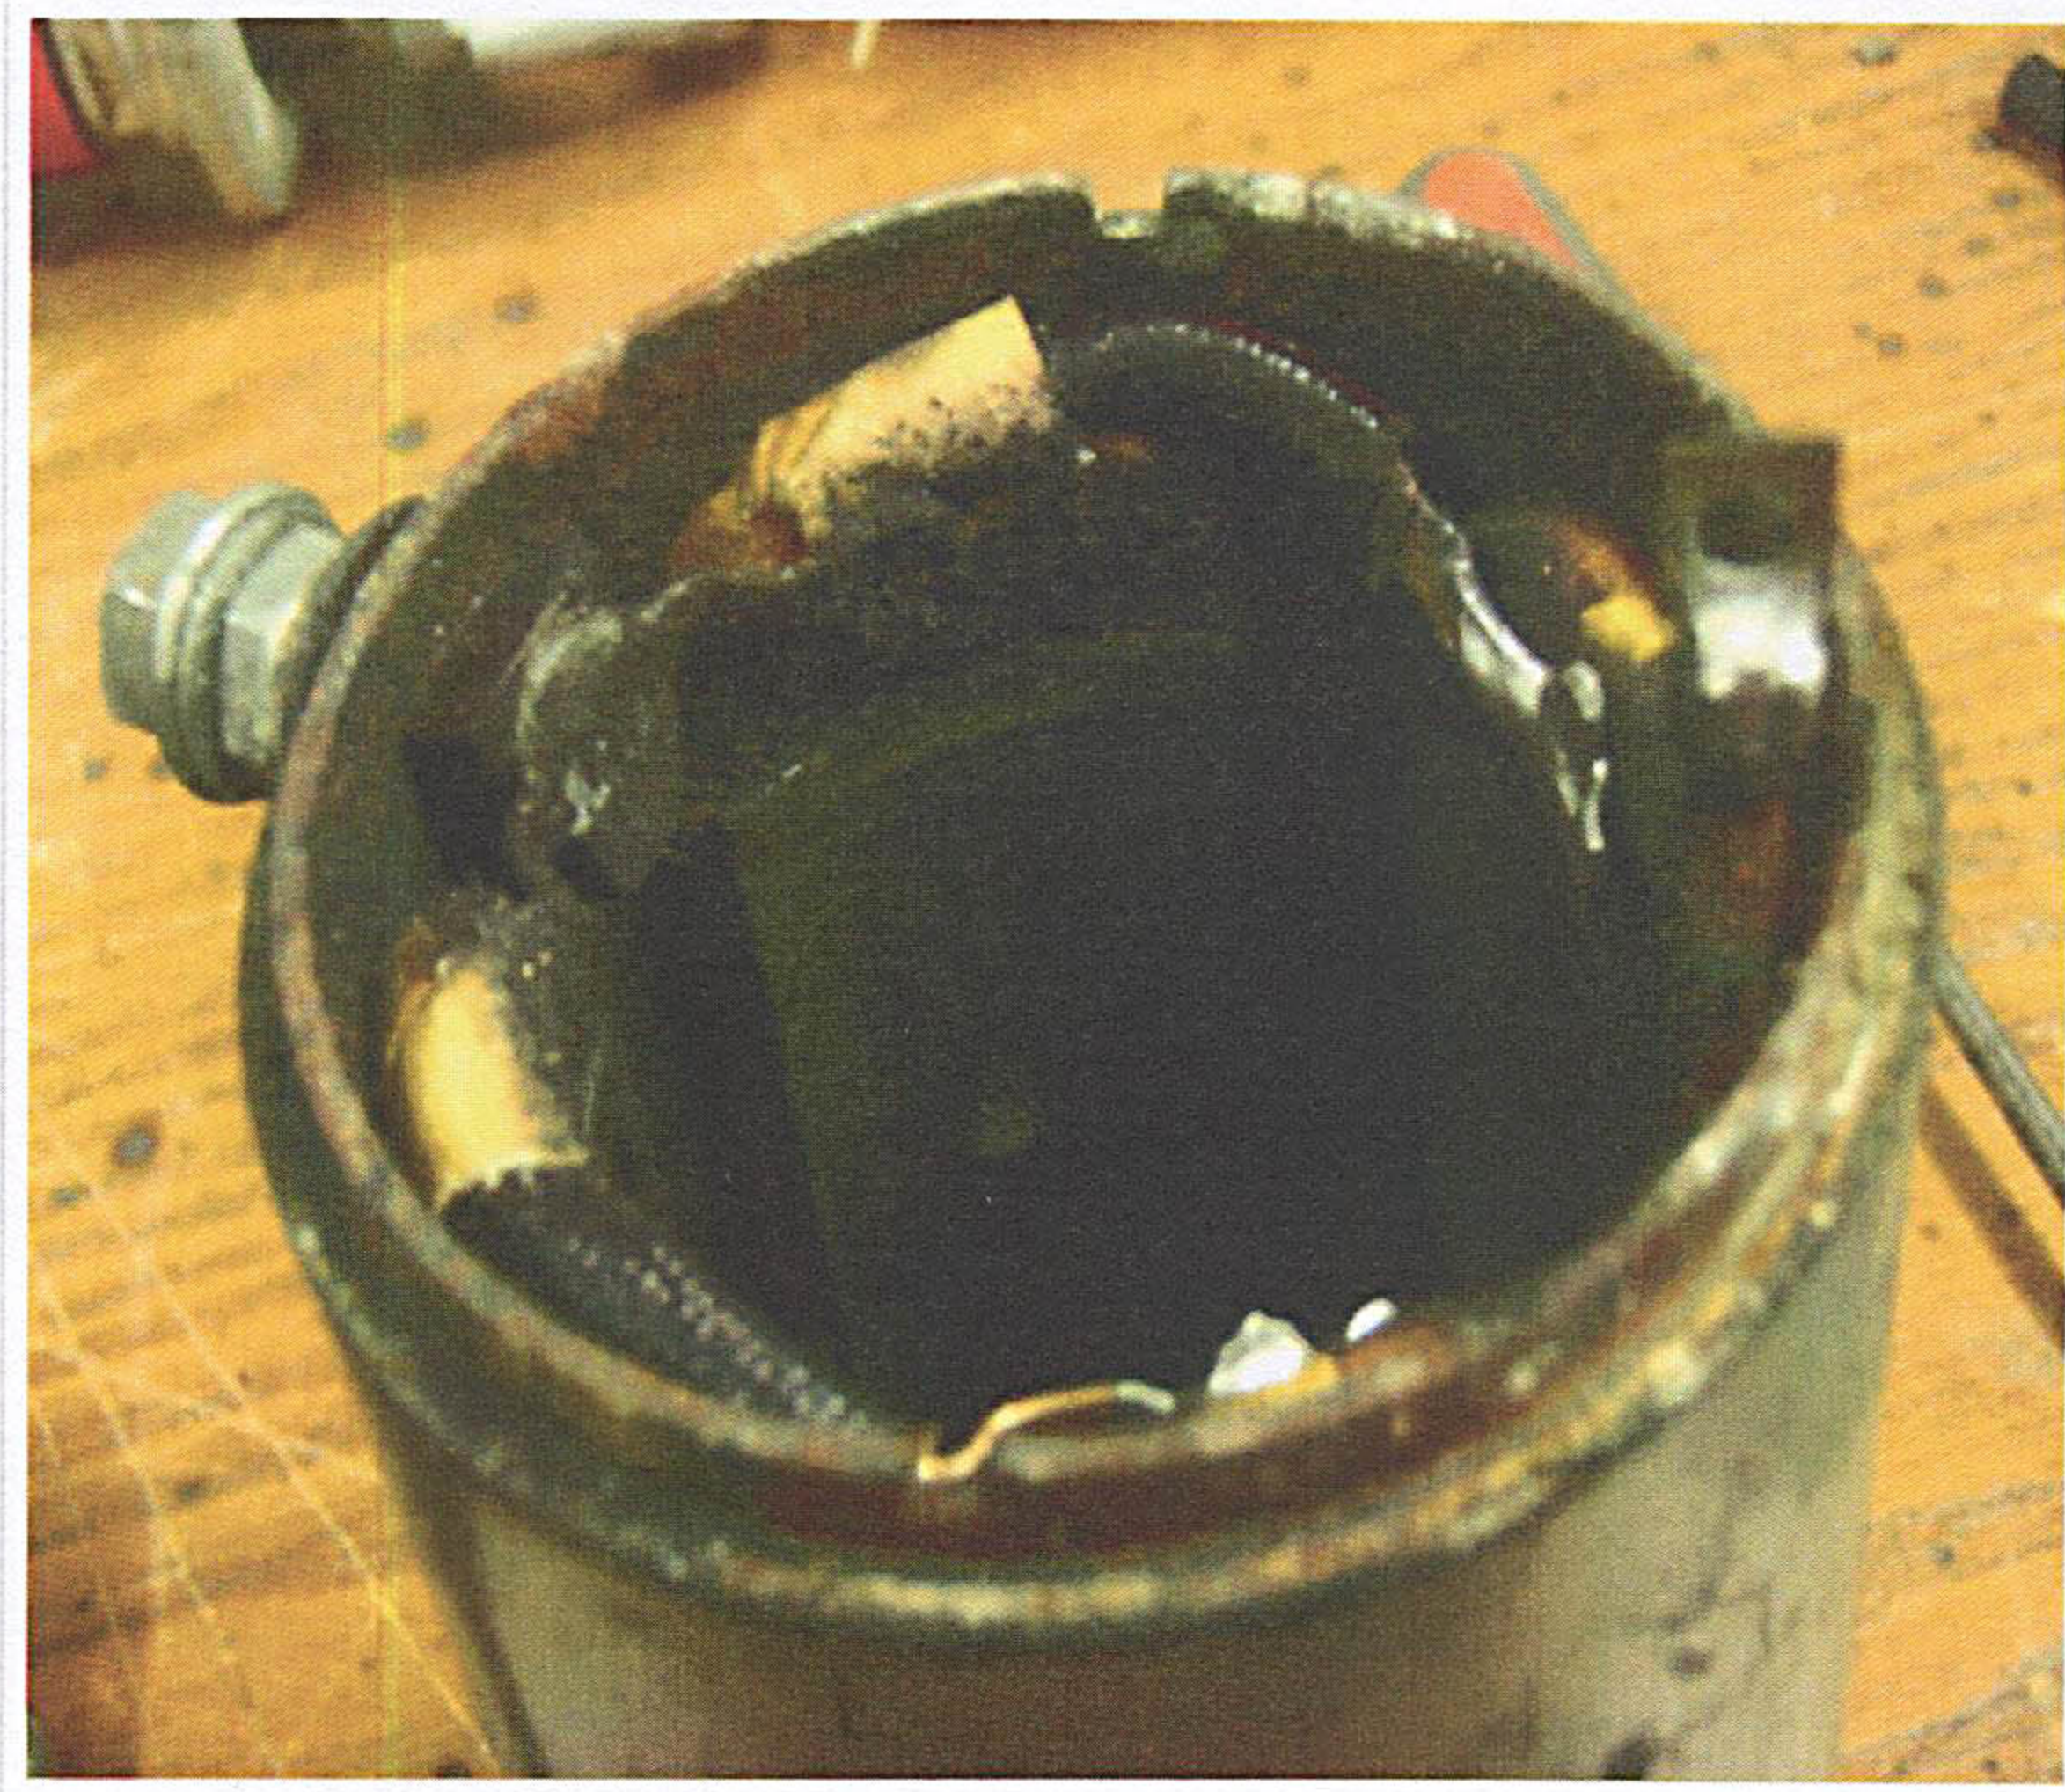
The base plate rests on this edge of the motor body, and with all the corrosion on this one it wasn't going to make a good contact. These motors are rated at 600W, and even with no additional engine cranking load on them thats pulling a hell of a lot of current that will need a better connection than the brush plate just being pressed onto that corroded metal edge will provide;

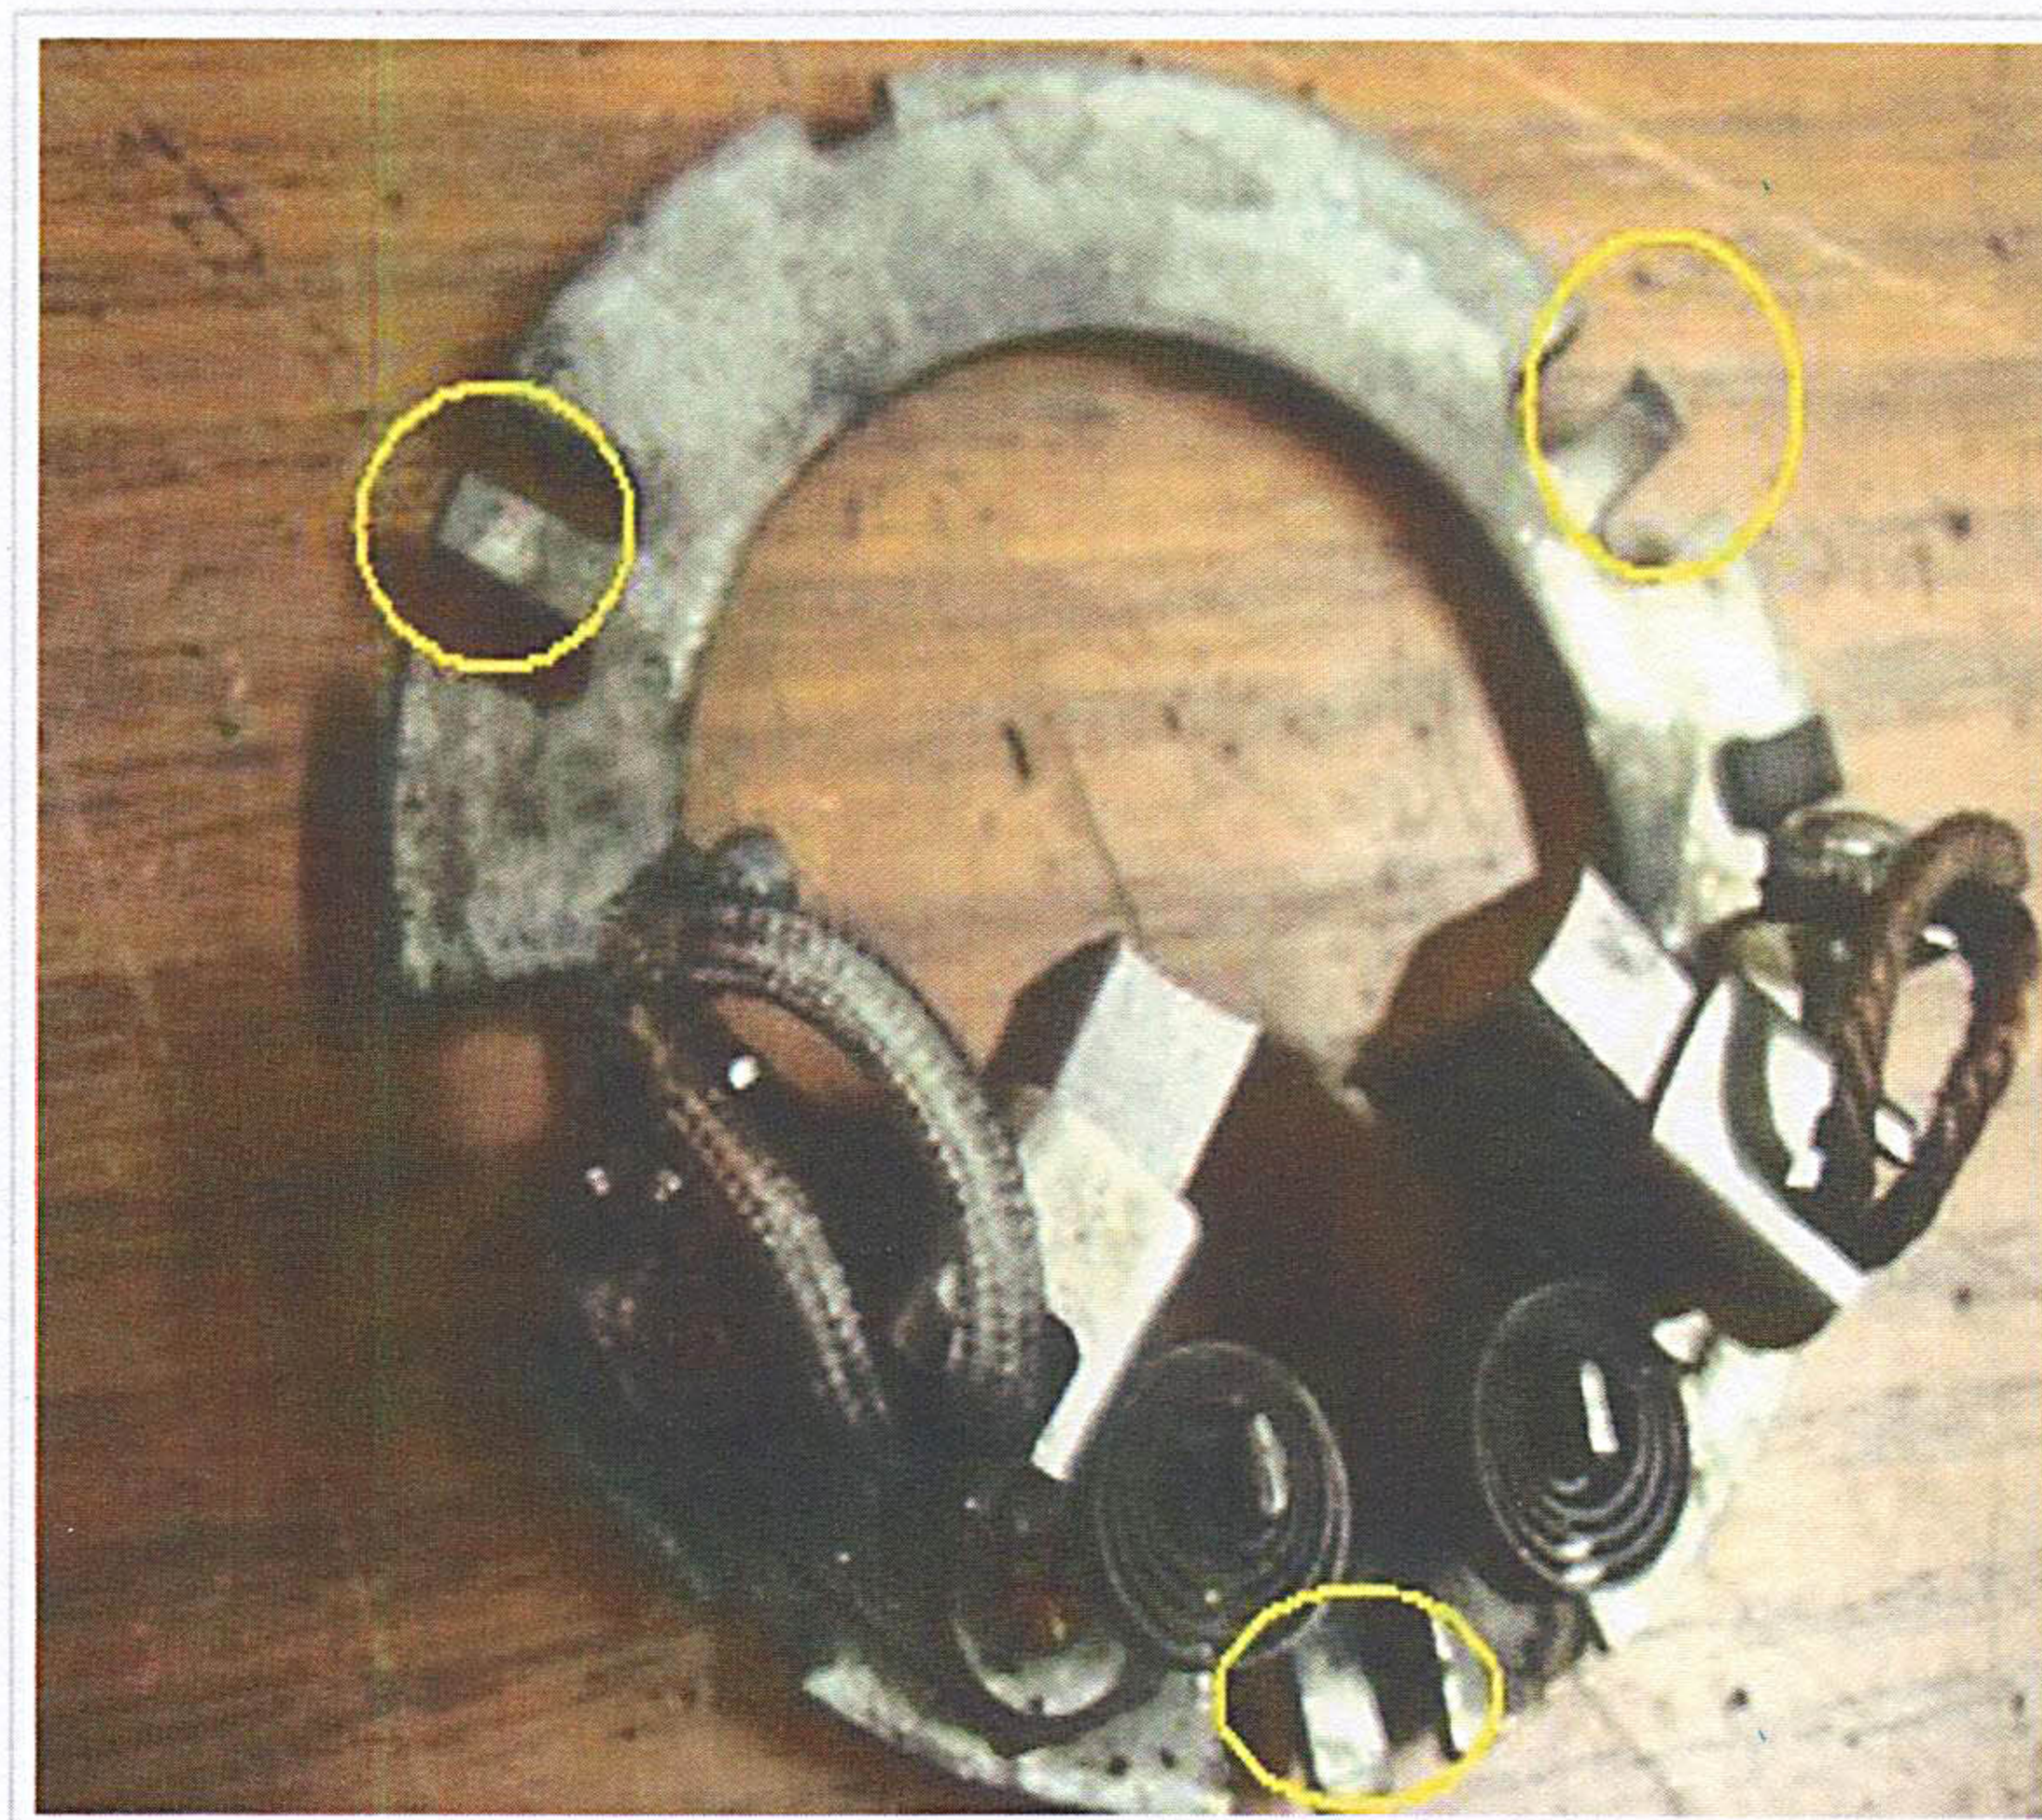
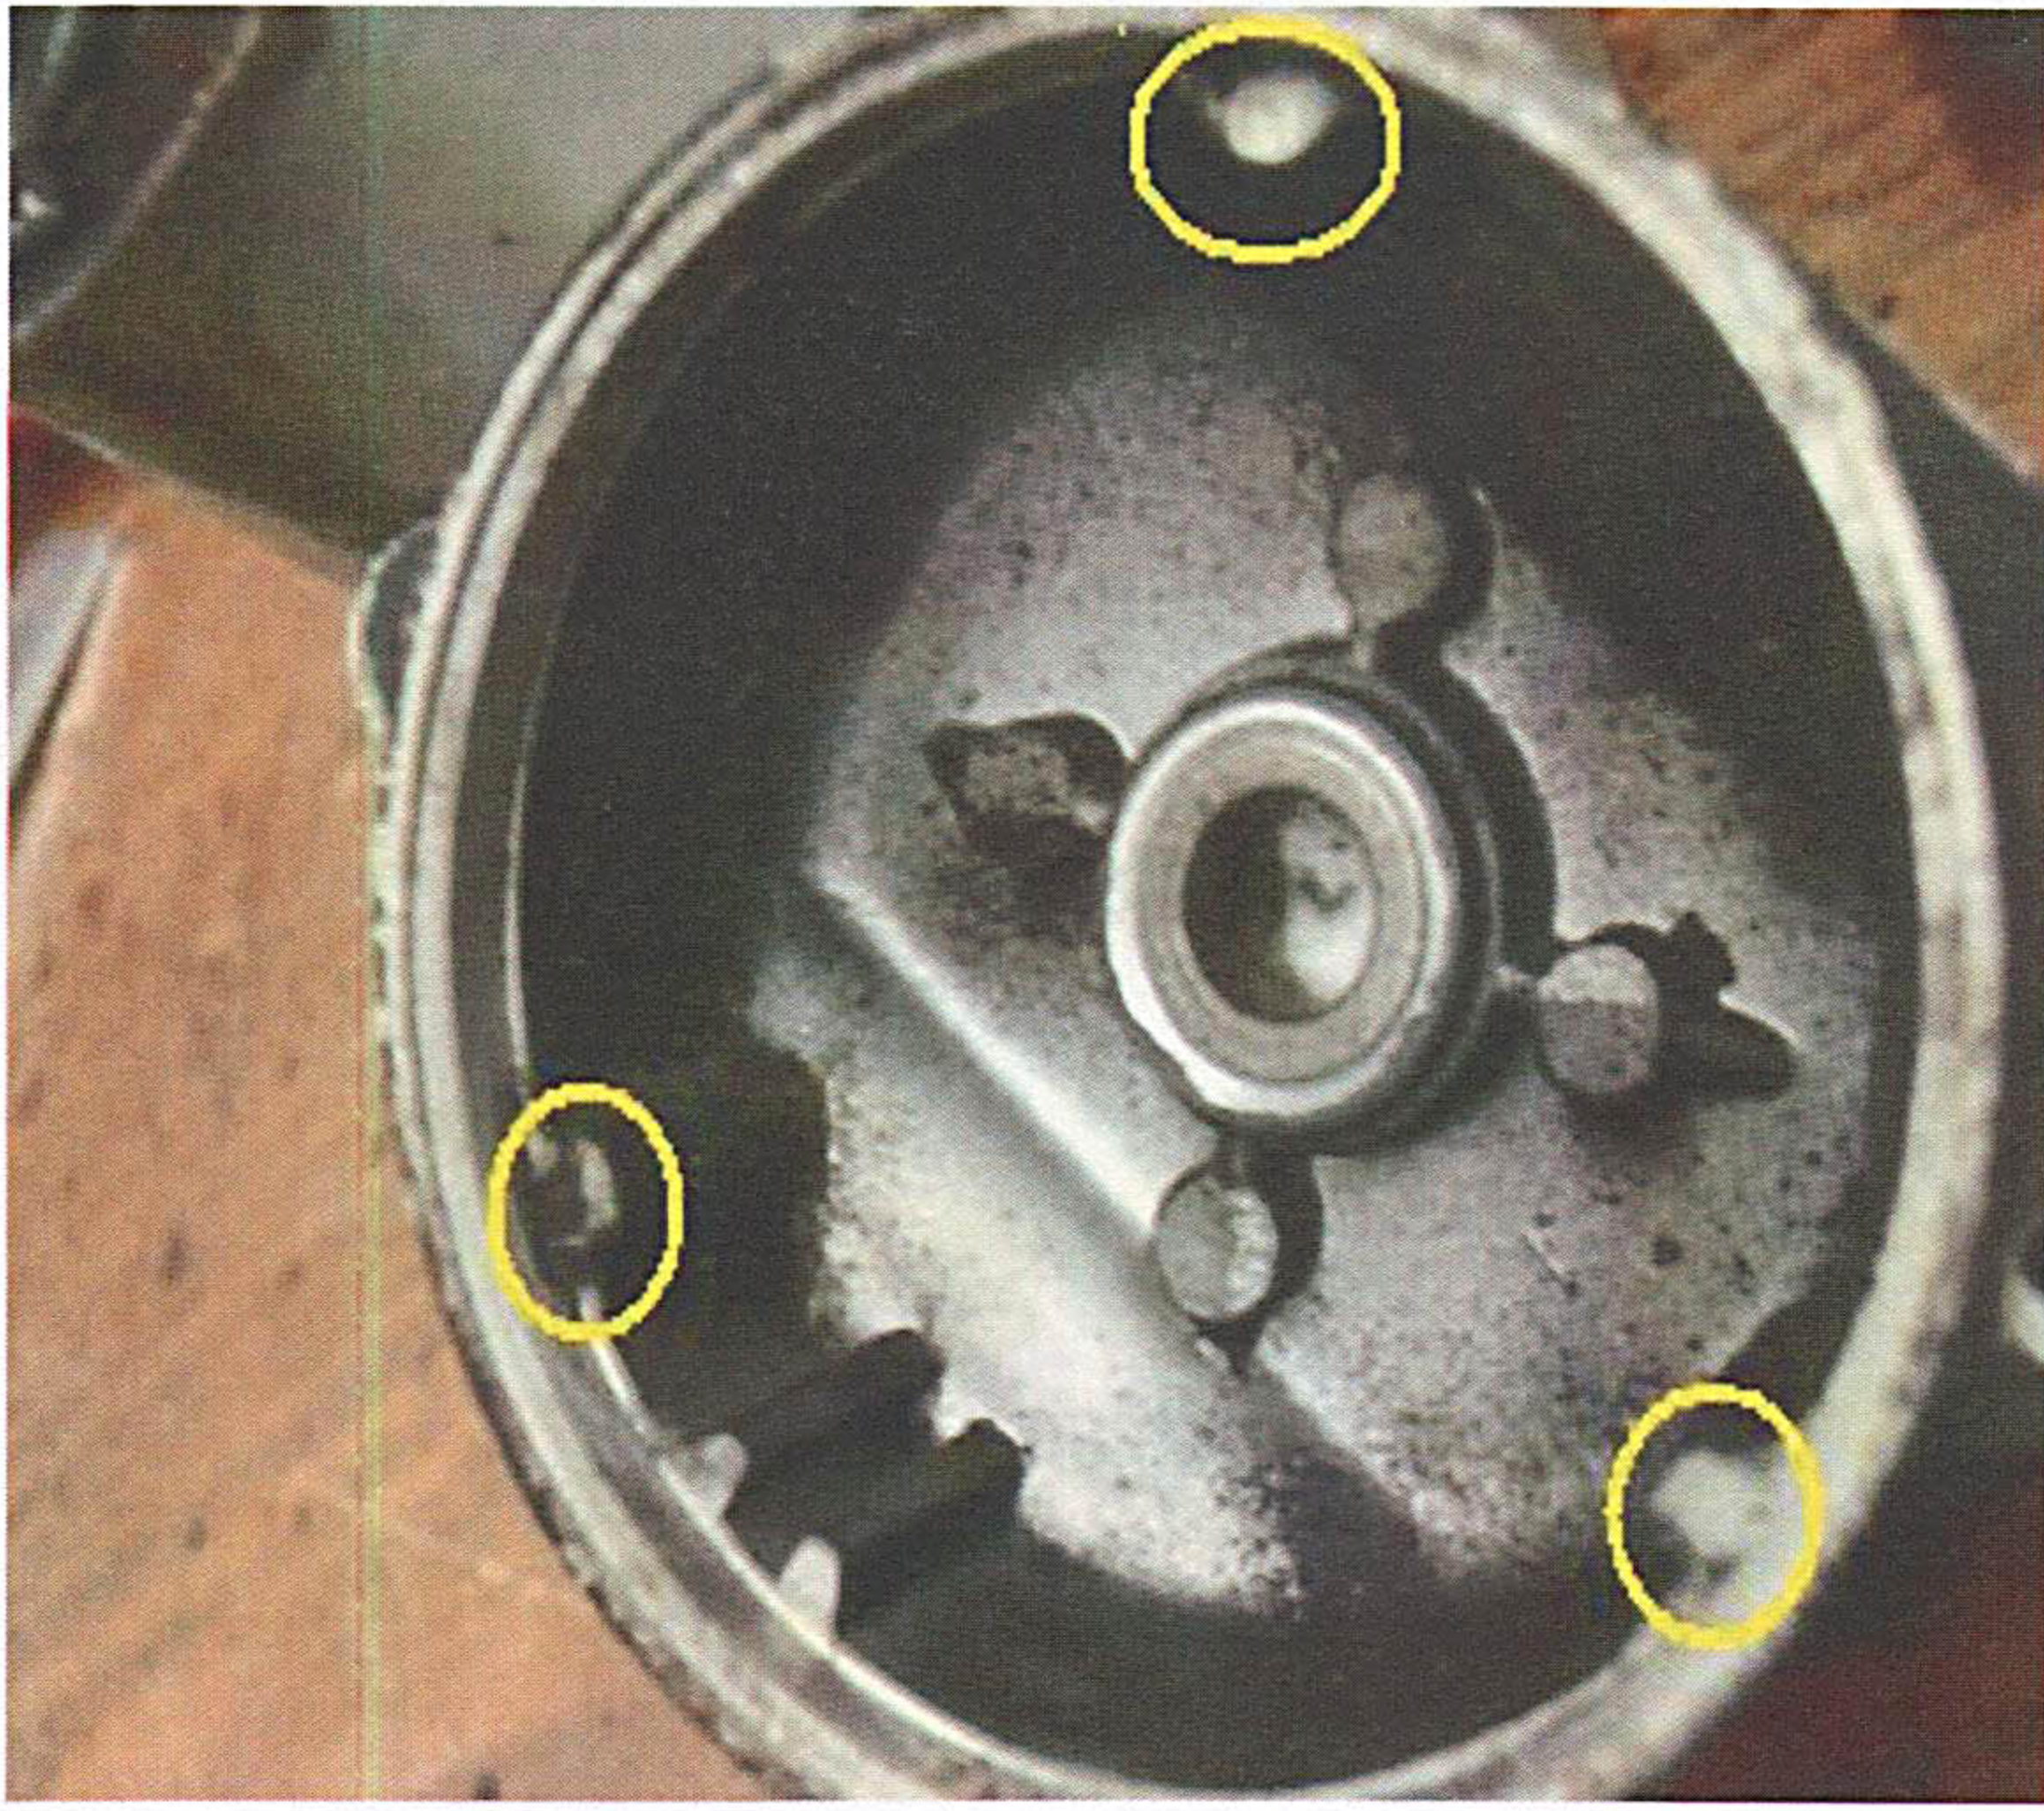
So i have a closer look at the base plate and see that there are three raised metal `tangs` that correspond to points on the end cap that are designed to either press the base plate down more firmly onto the body or are additional earth connections to the cap, or both - probably the latter, though;

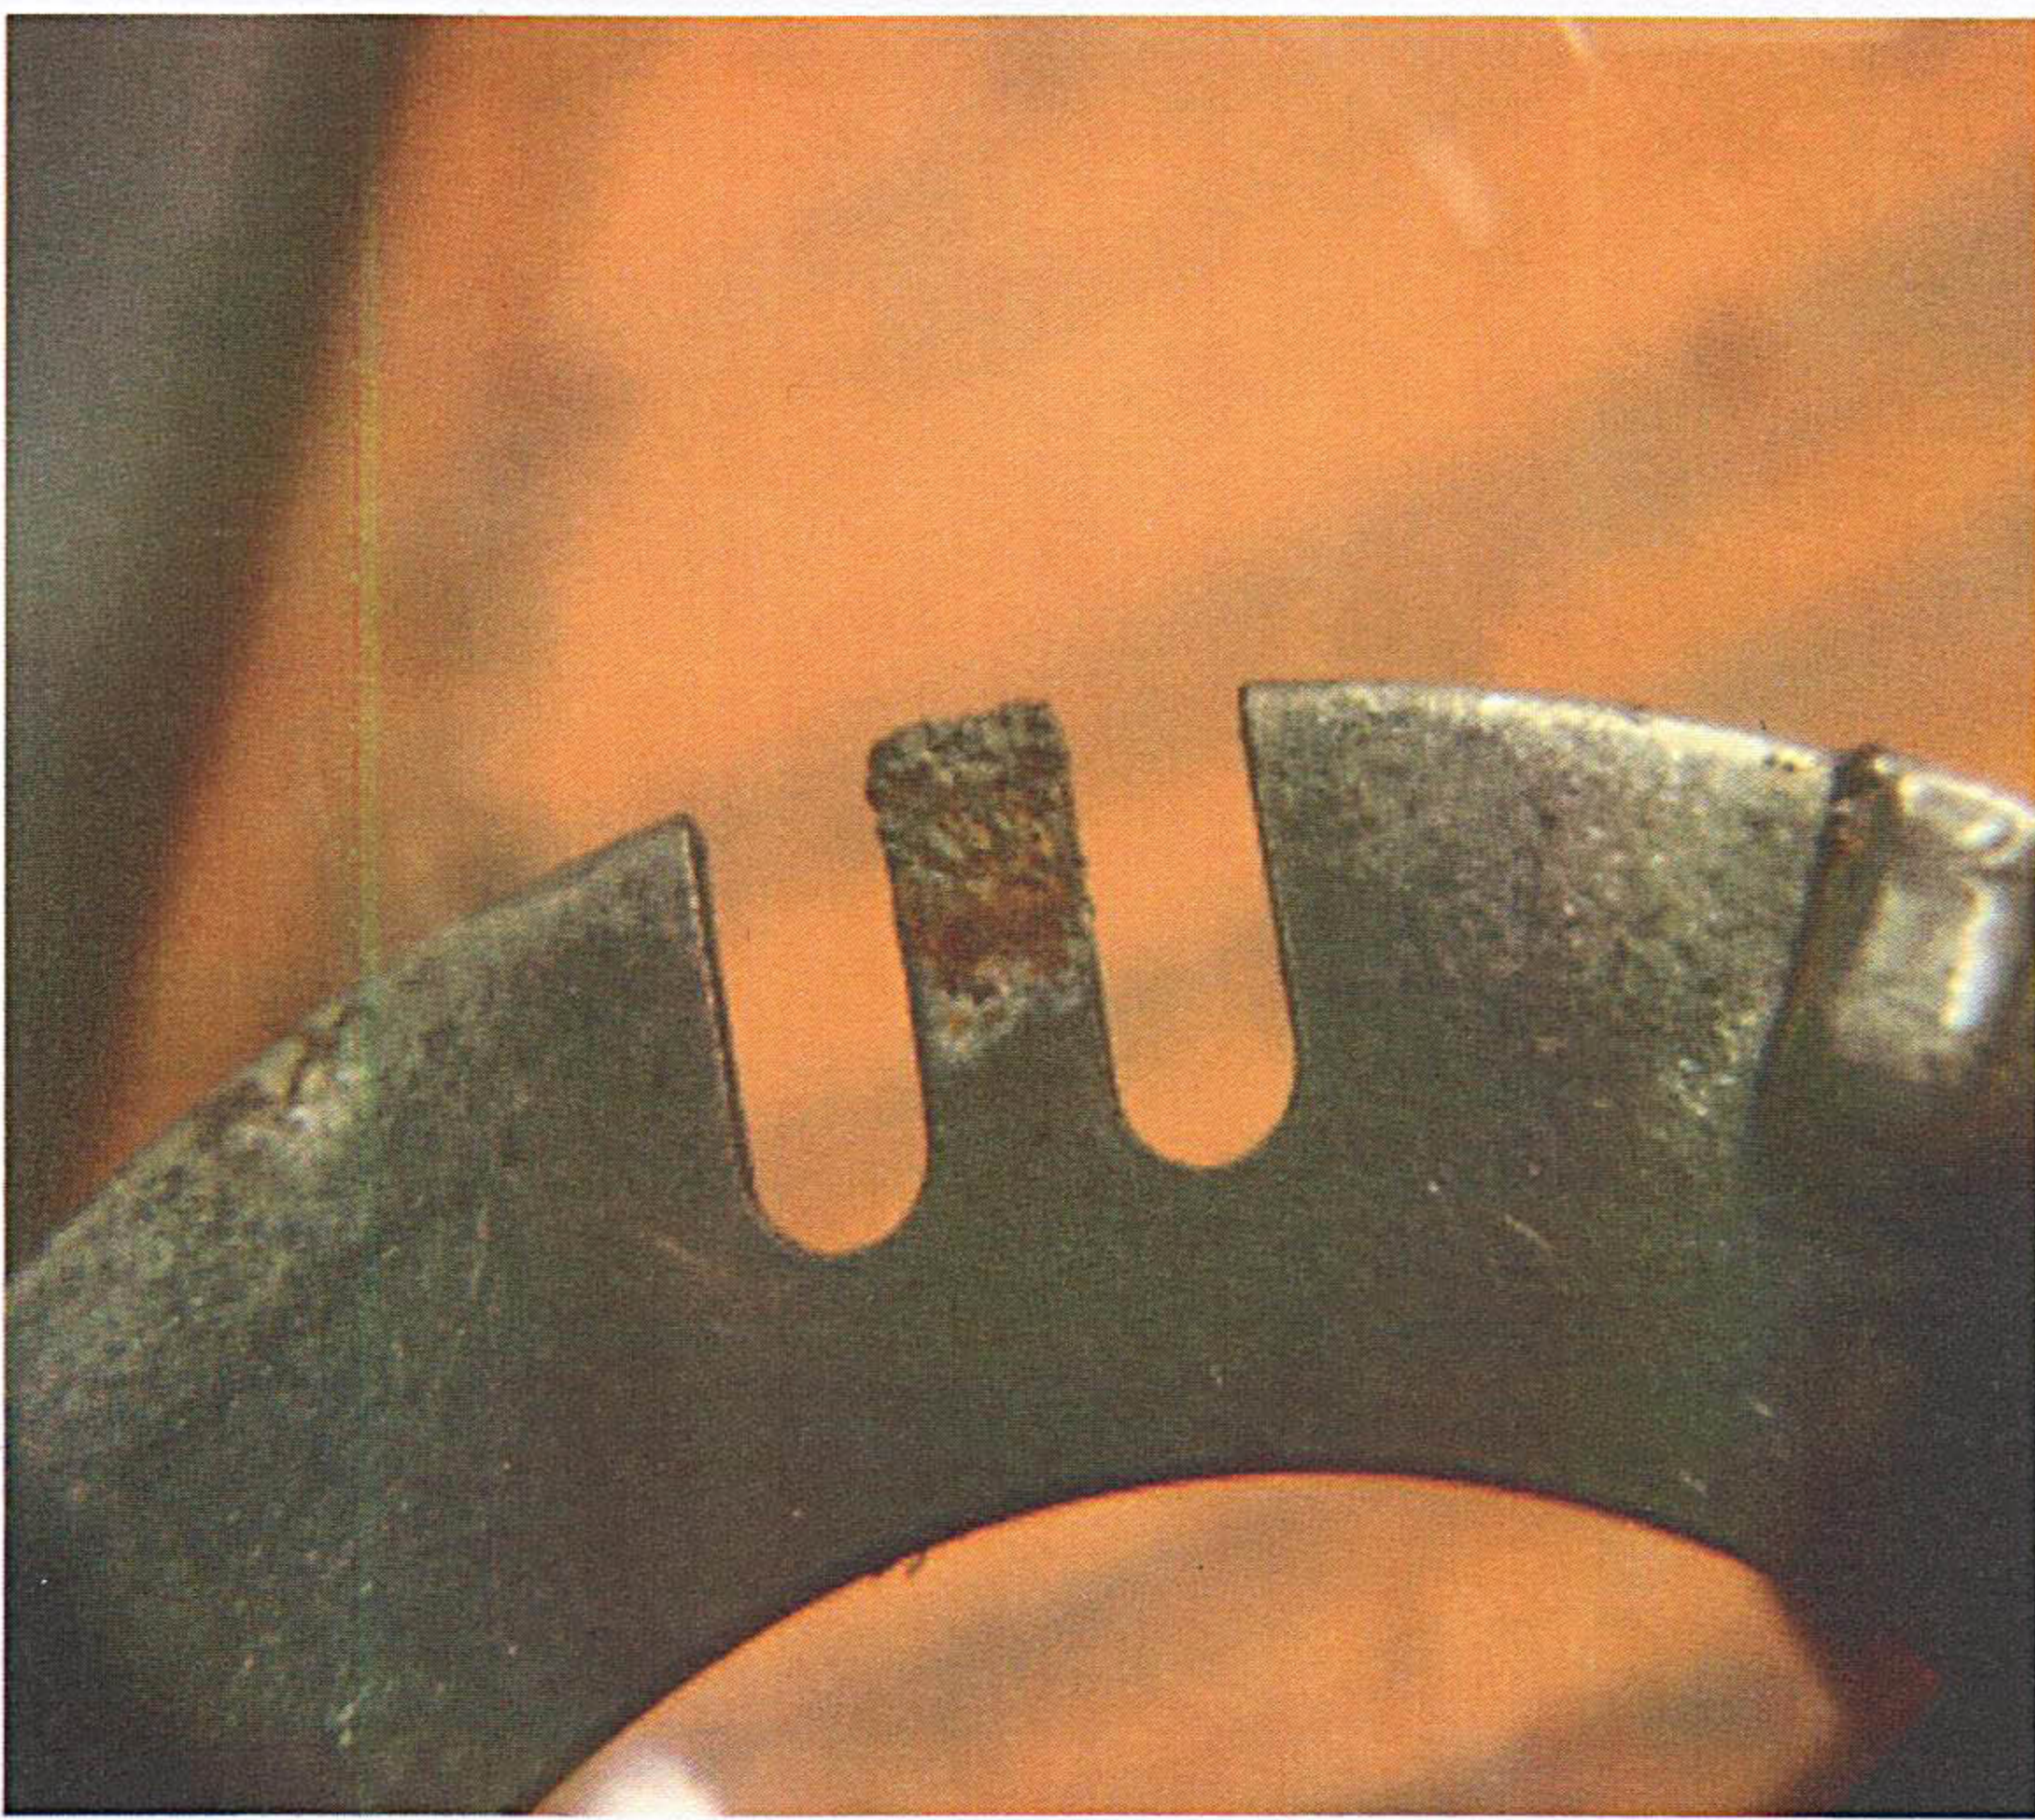
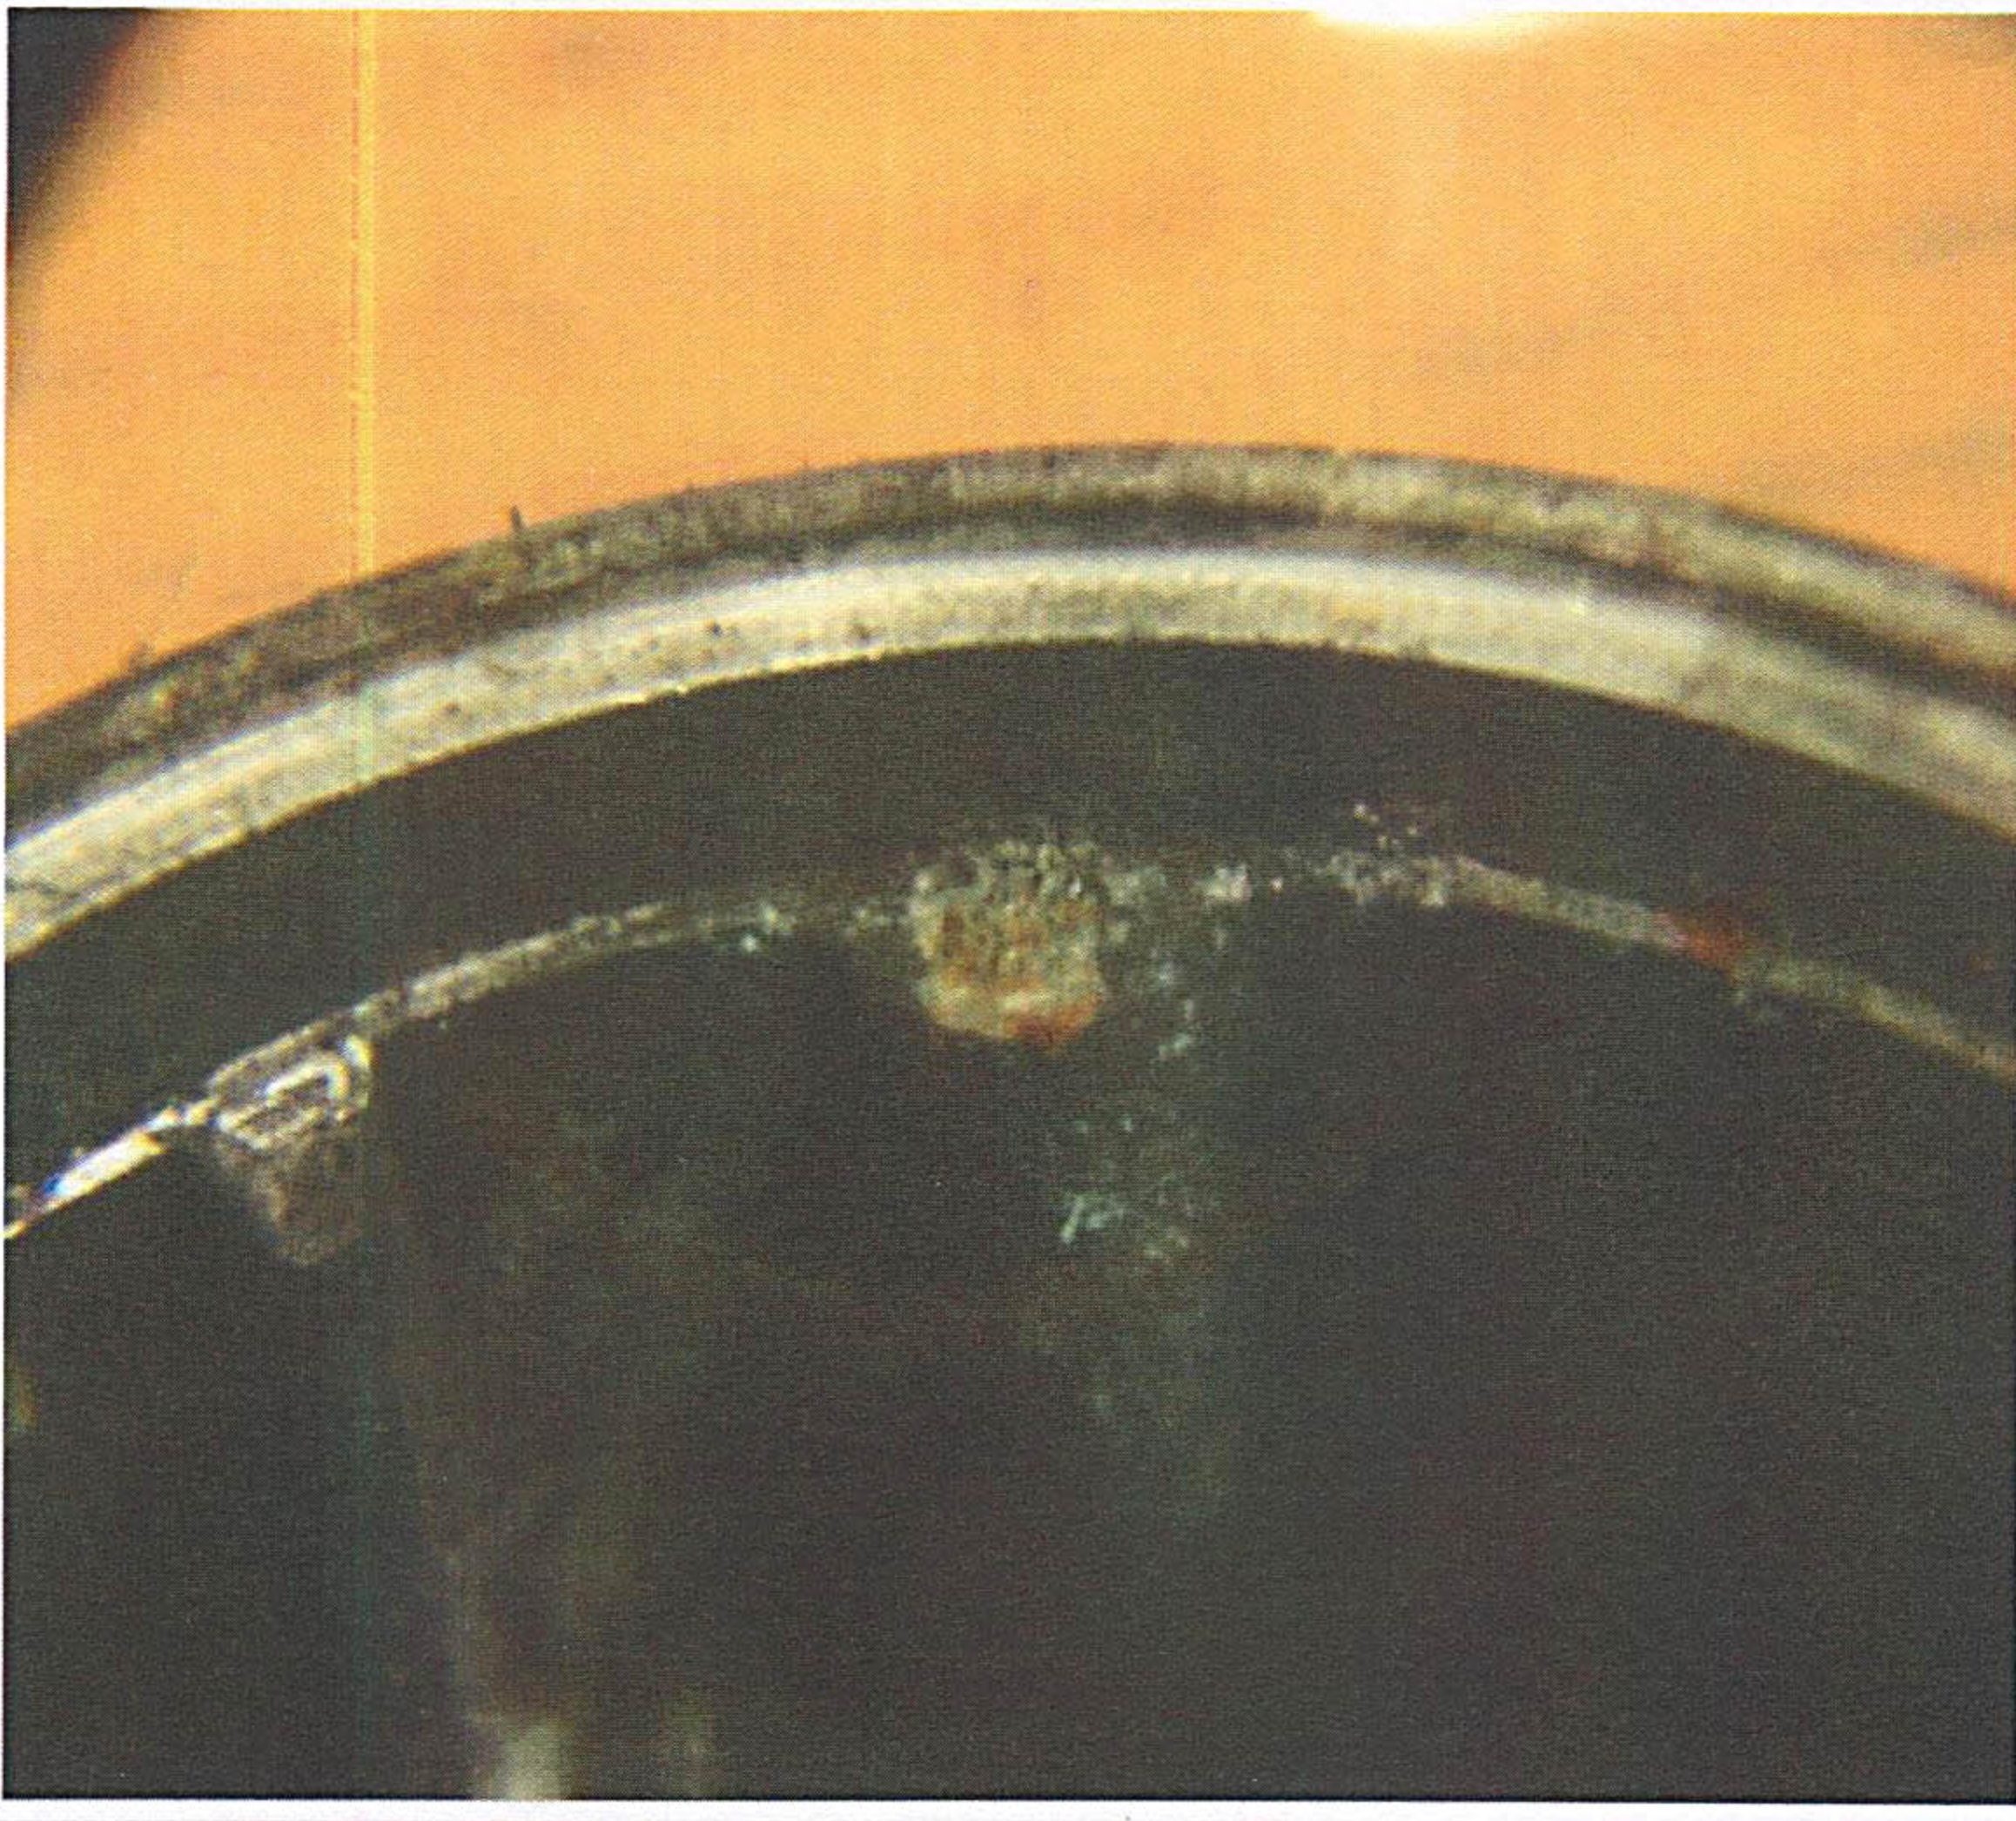
However, on inspection of these tangs and the rear end cap it is obvious that they too have suffered - the tangs are pitted, burnt and corroded, and the end cap eroded where there has been arcing across the two;

It seems like this is reason why this starter motor was turning over so slowly - the poor earth path due to the pitted/corroded tangs and the eroded end cap providing a high resistance to the large amount of current trying to flow through them.

To fix this i could just clean everything up to new bright metal to make good the contact again but the components are already compromised due to arcing/rusting etc so i don`t think this would be a reliable repair, and it`s just restoring to what seems like an already weak point in the design of the starter motor - the three tangs only provide point-contact with the end cap with insufficient area to provide good conductivity, especially after years of use and degradation. So i thought about providing a seperate, dedicated earth strap from the base plate direct to the end cap which would provide a more permanent, positive, and secure route for the earth current to take.
