## OFAPARS` V TWINS.

### **Lethargic starter motor.**

### 650 starter motor.

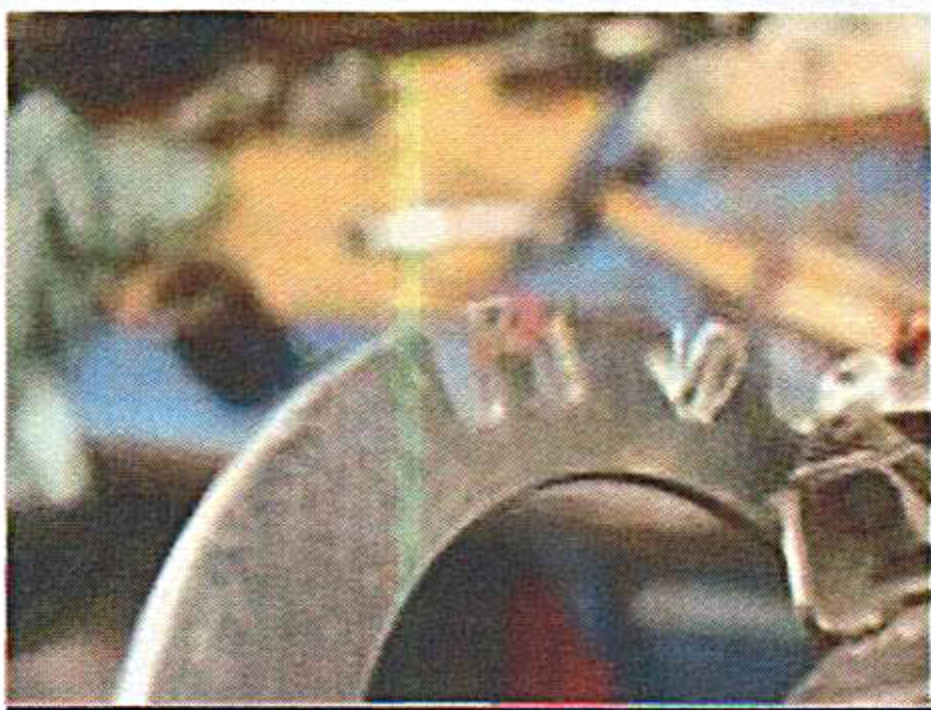
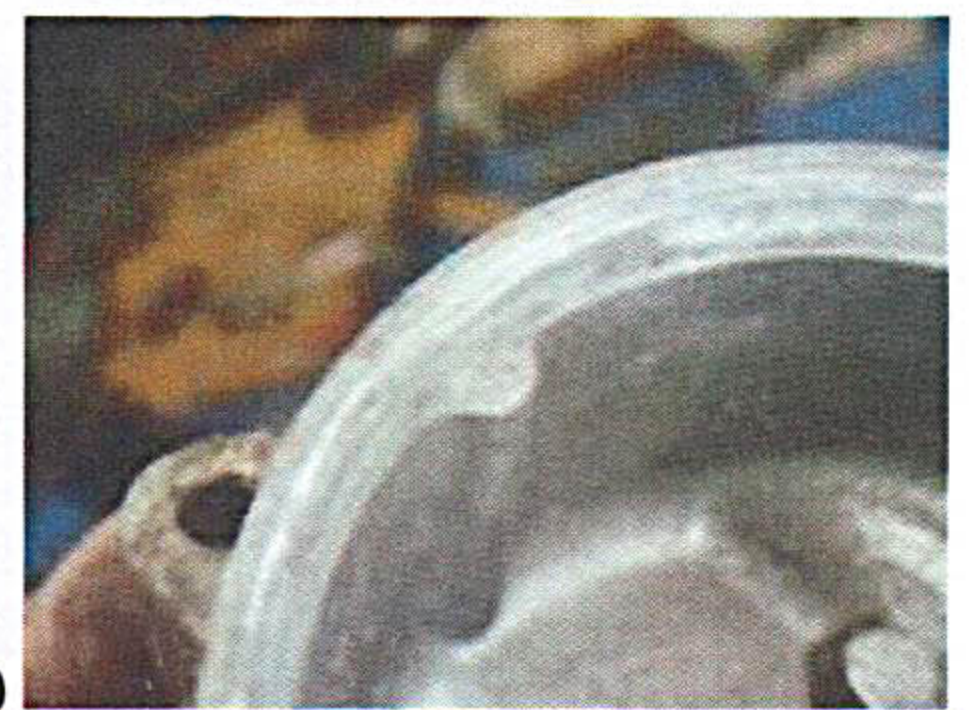
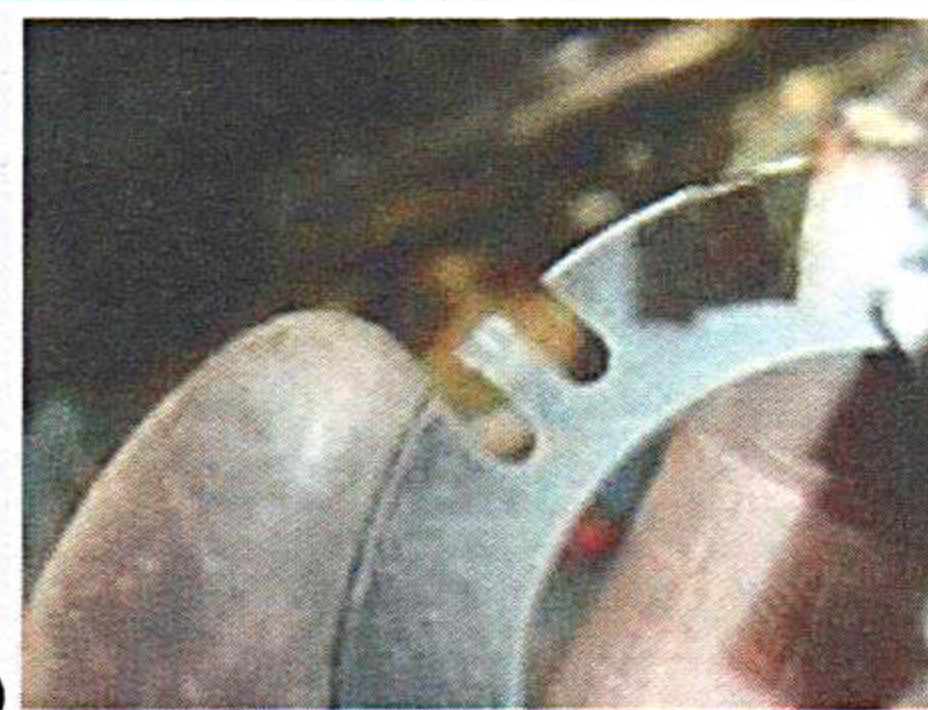
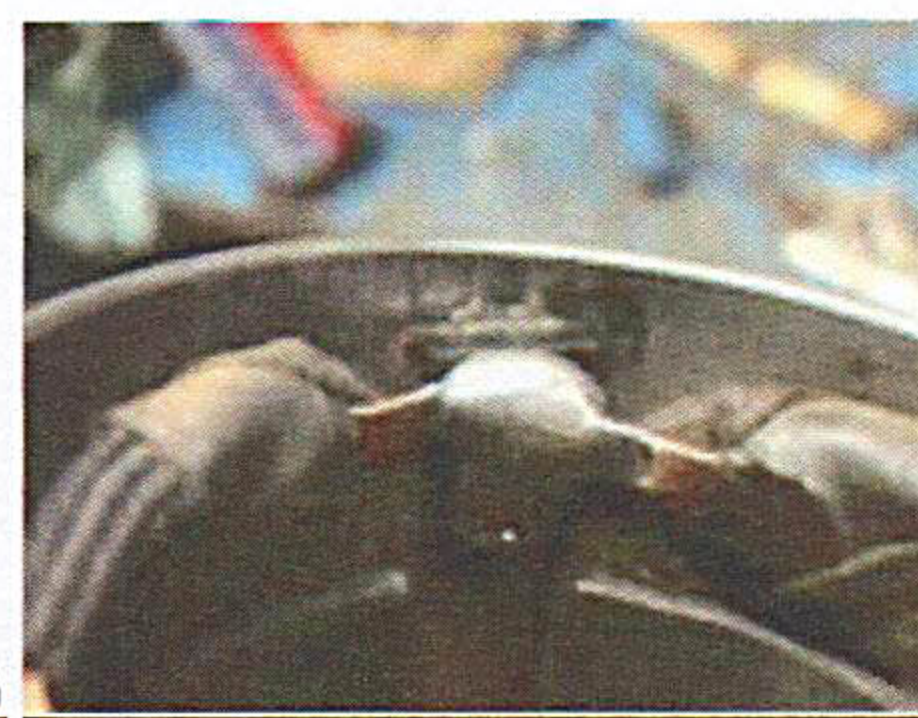
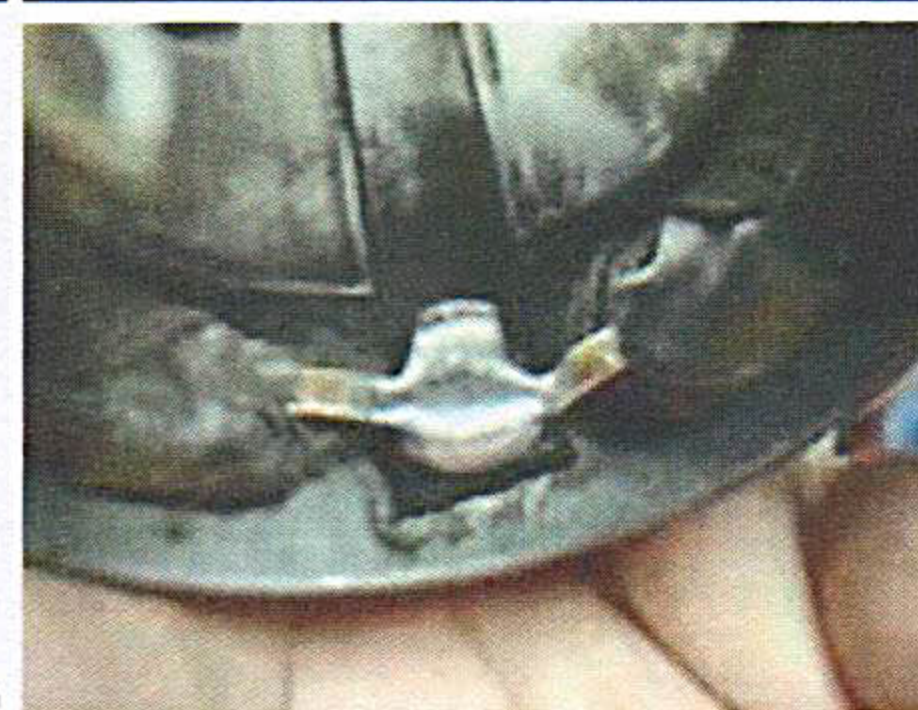
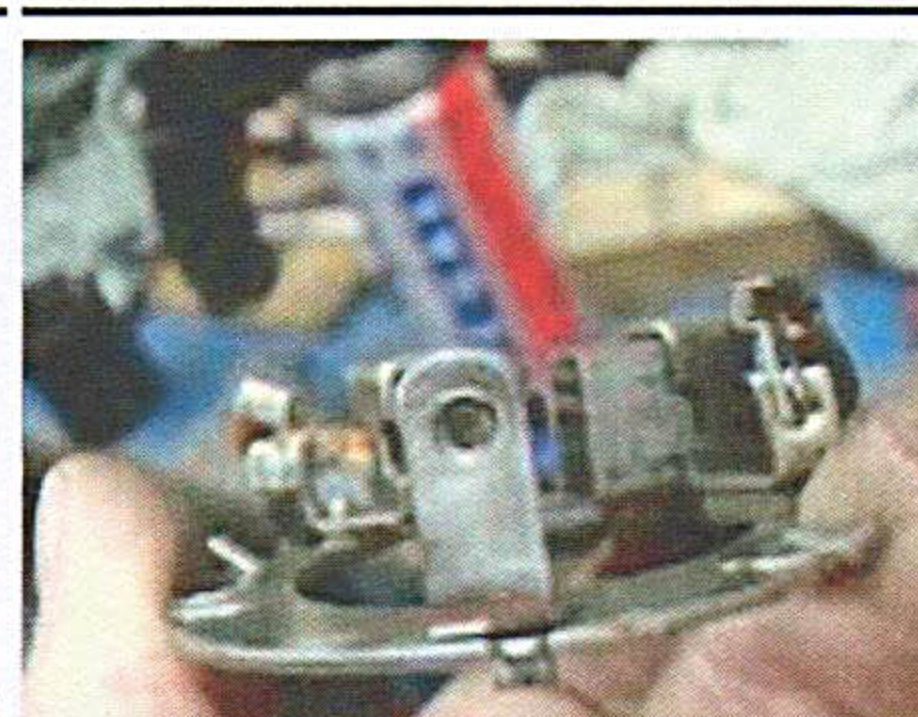
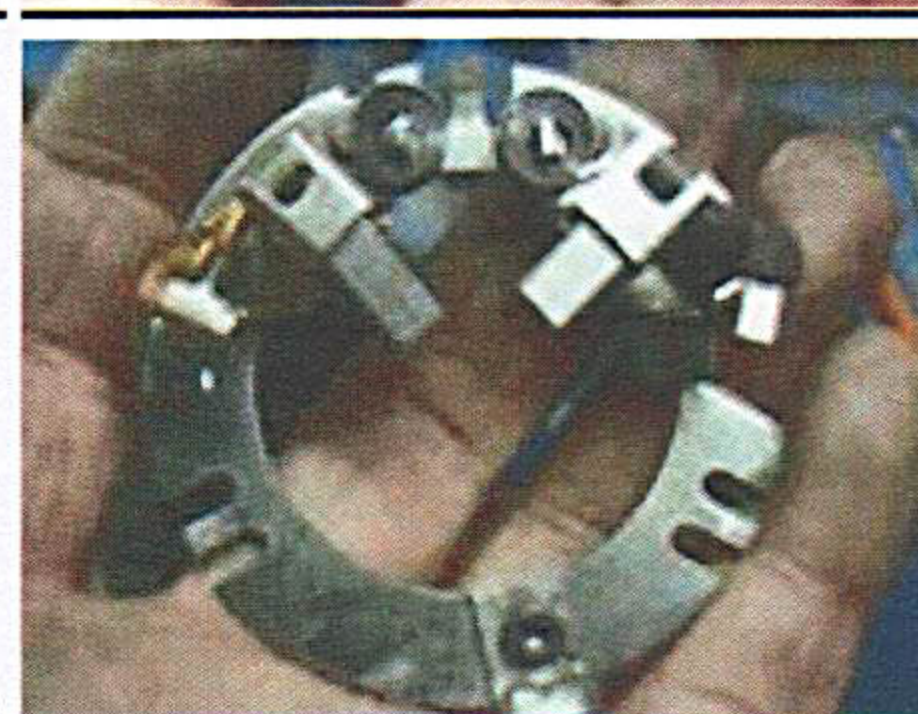
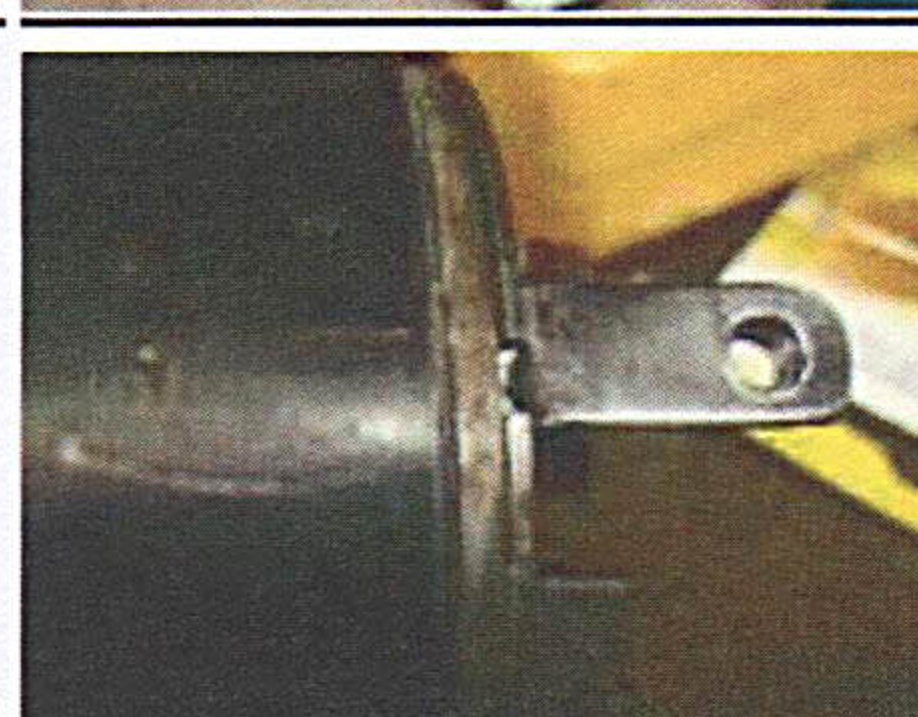
Doing another starter motor repair job i took some more pics of the corroded tangs. On this one i re-soldered the bus and these pics show the preferred location for the strap near to the index marks on the motors body;

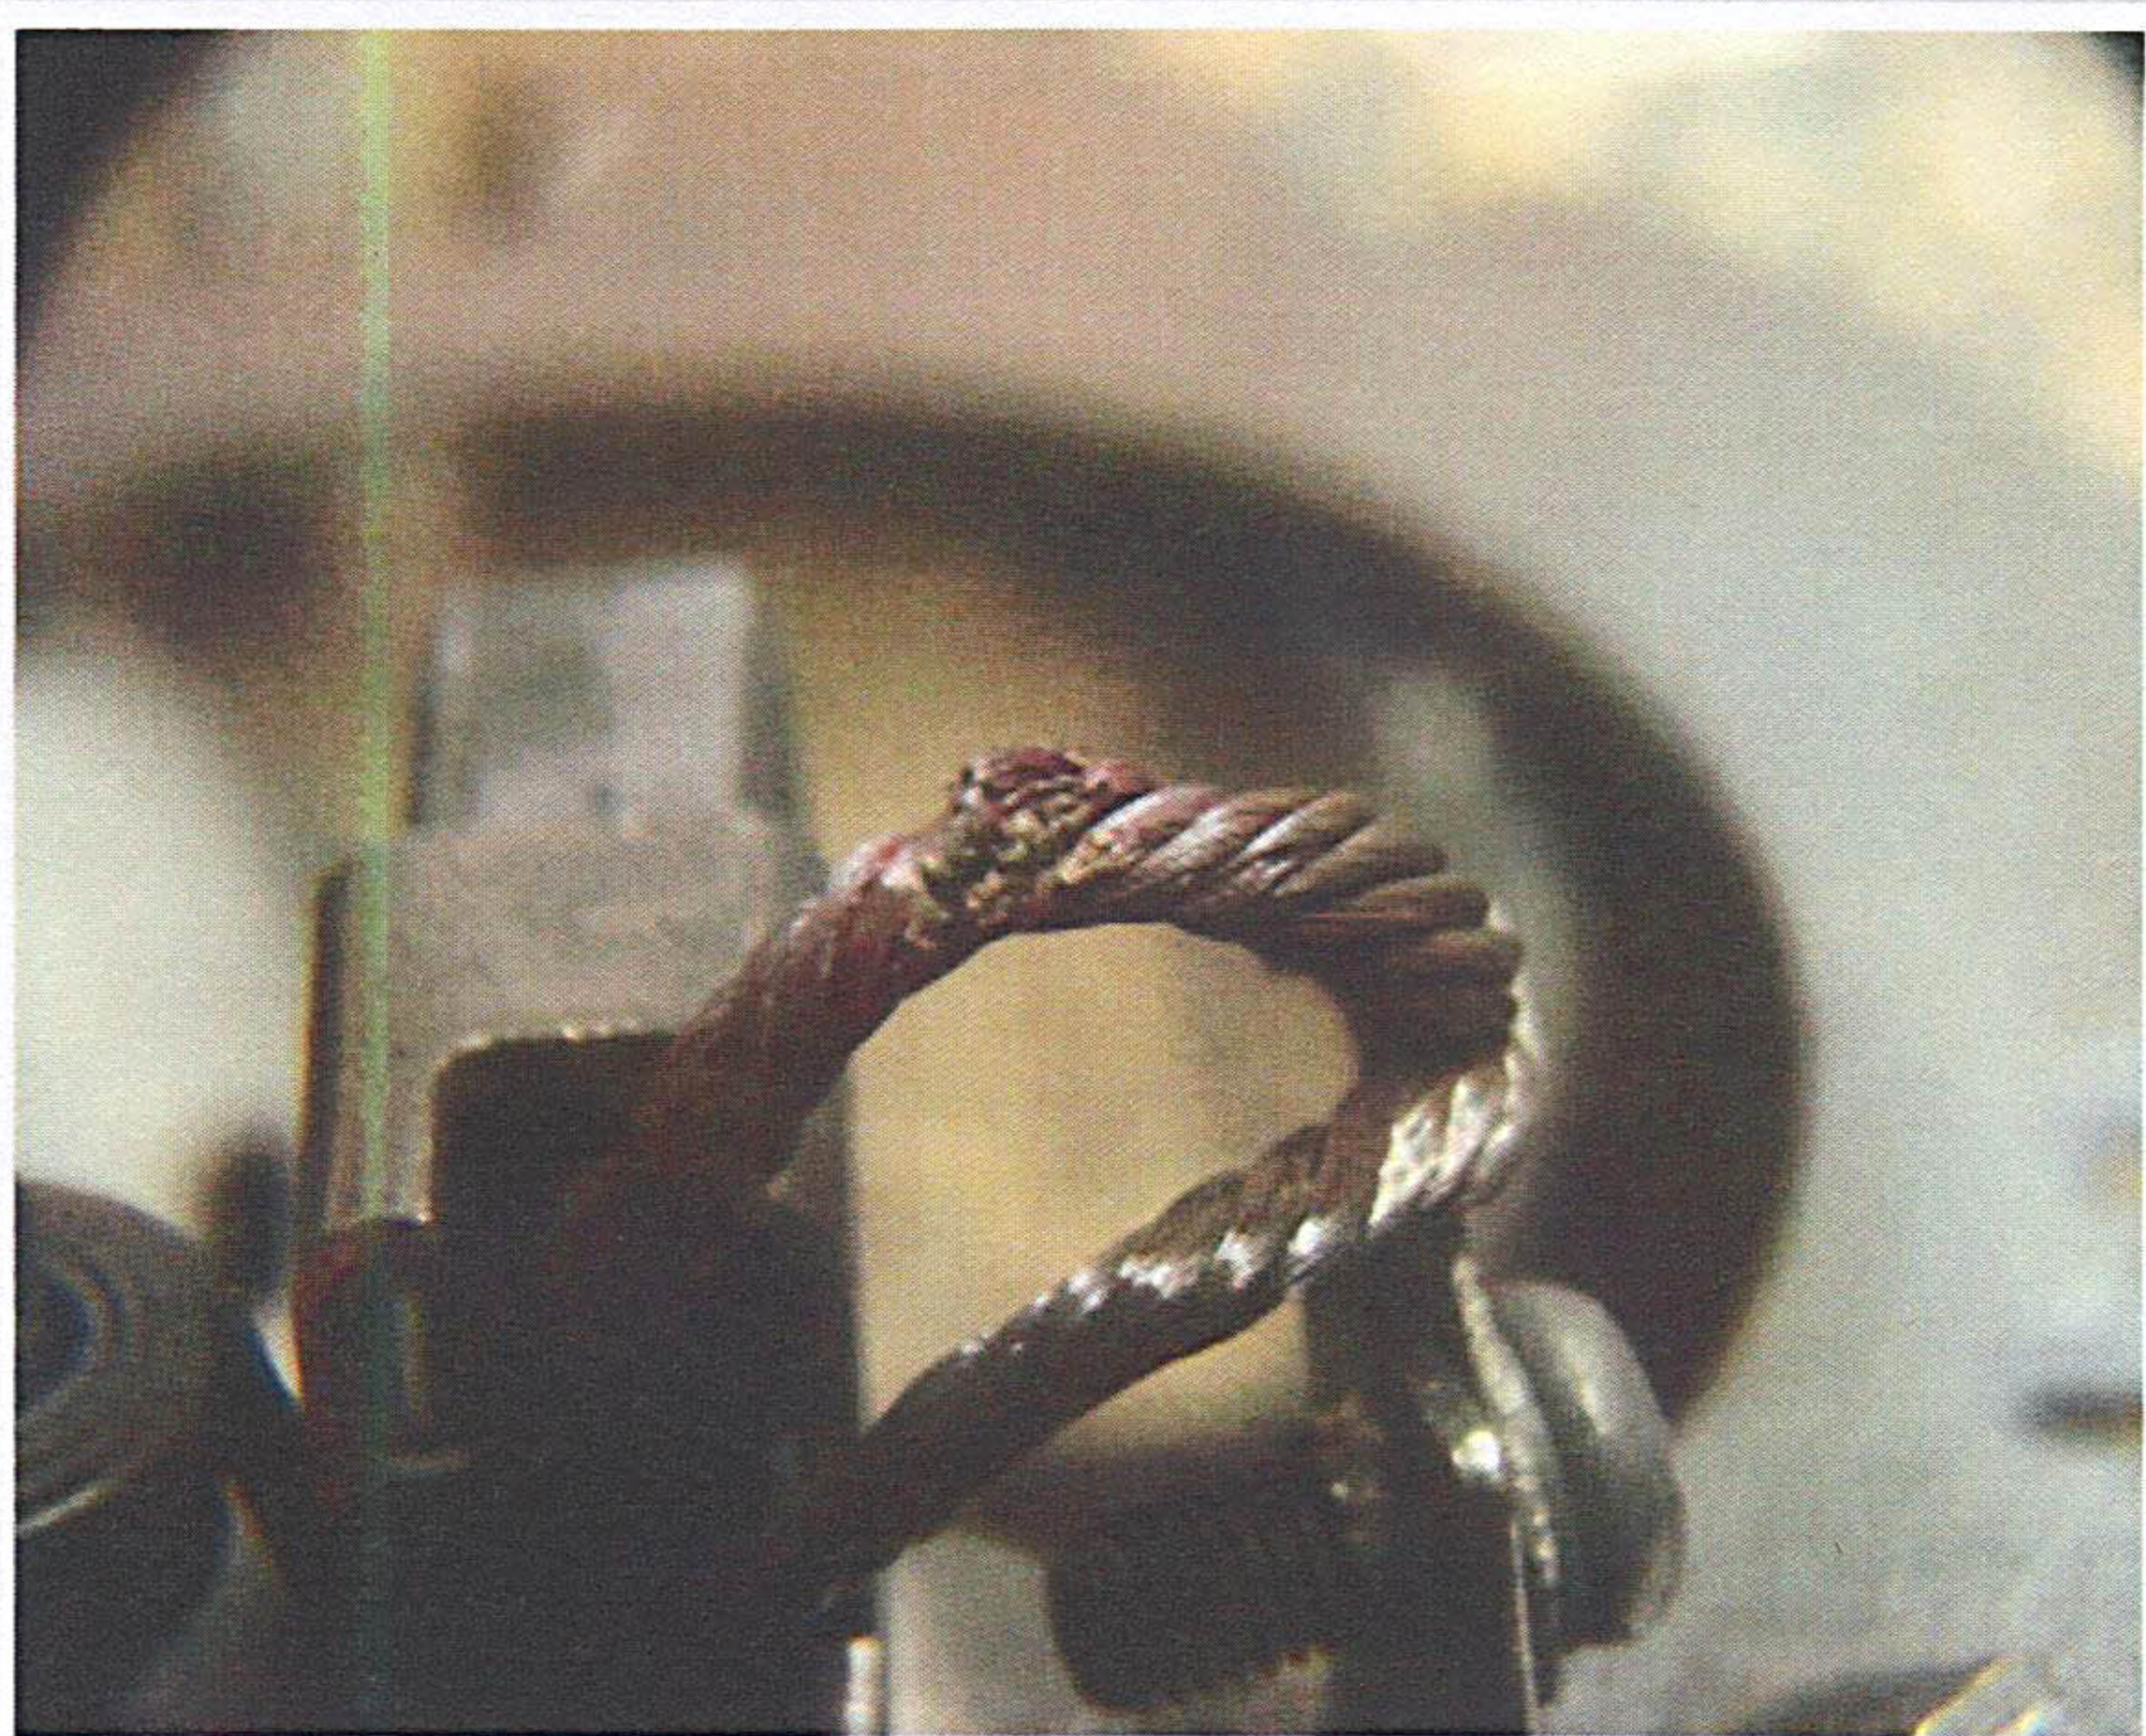
On stripping down another starter motor i saw a further clue that the current was not taking the intended path through the end cap via the base plate. Electricity always takes the easiest route, and rather than try and flow accross the high resistance of the base plate tangs the current through this motor took the less resistive route to earth where there was contact between the earth brush wire and the inside of the cap. This caused arcing between the two and melting the copper wire;

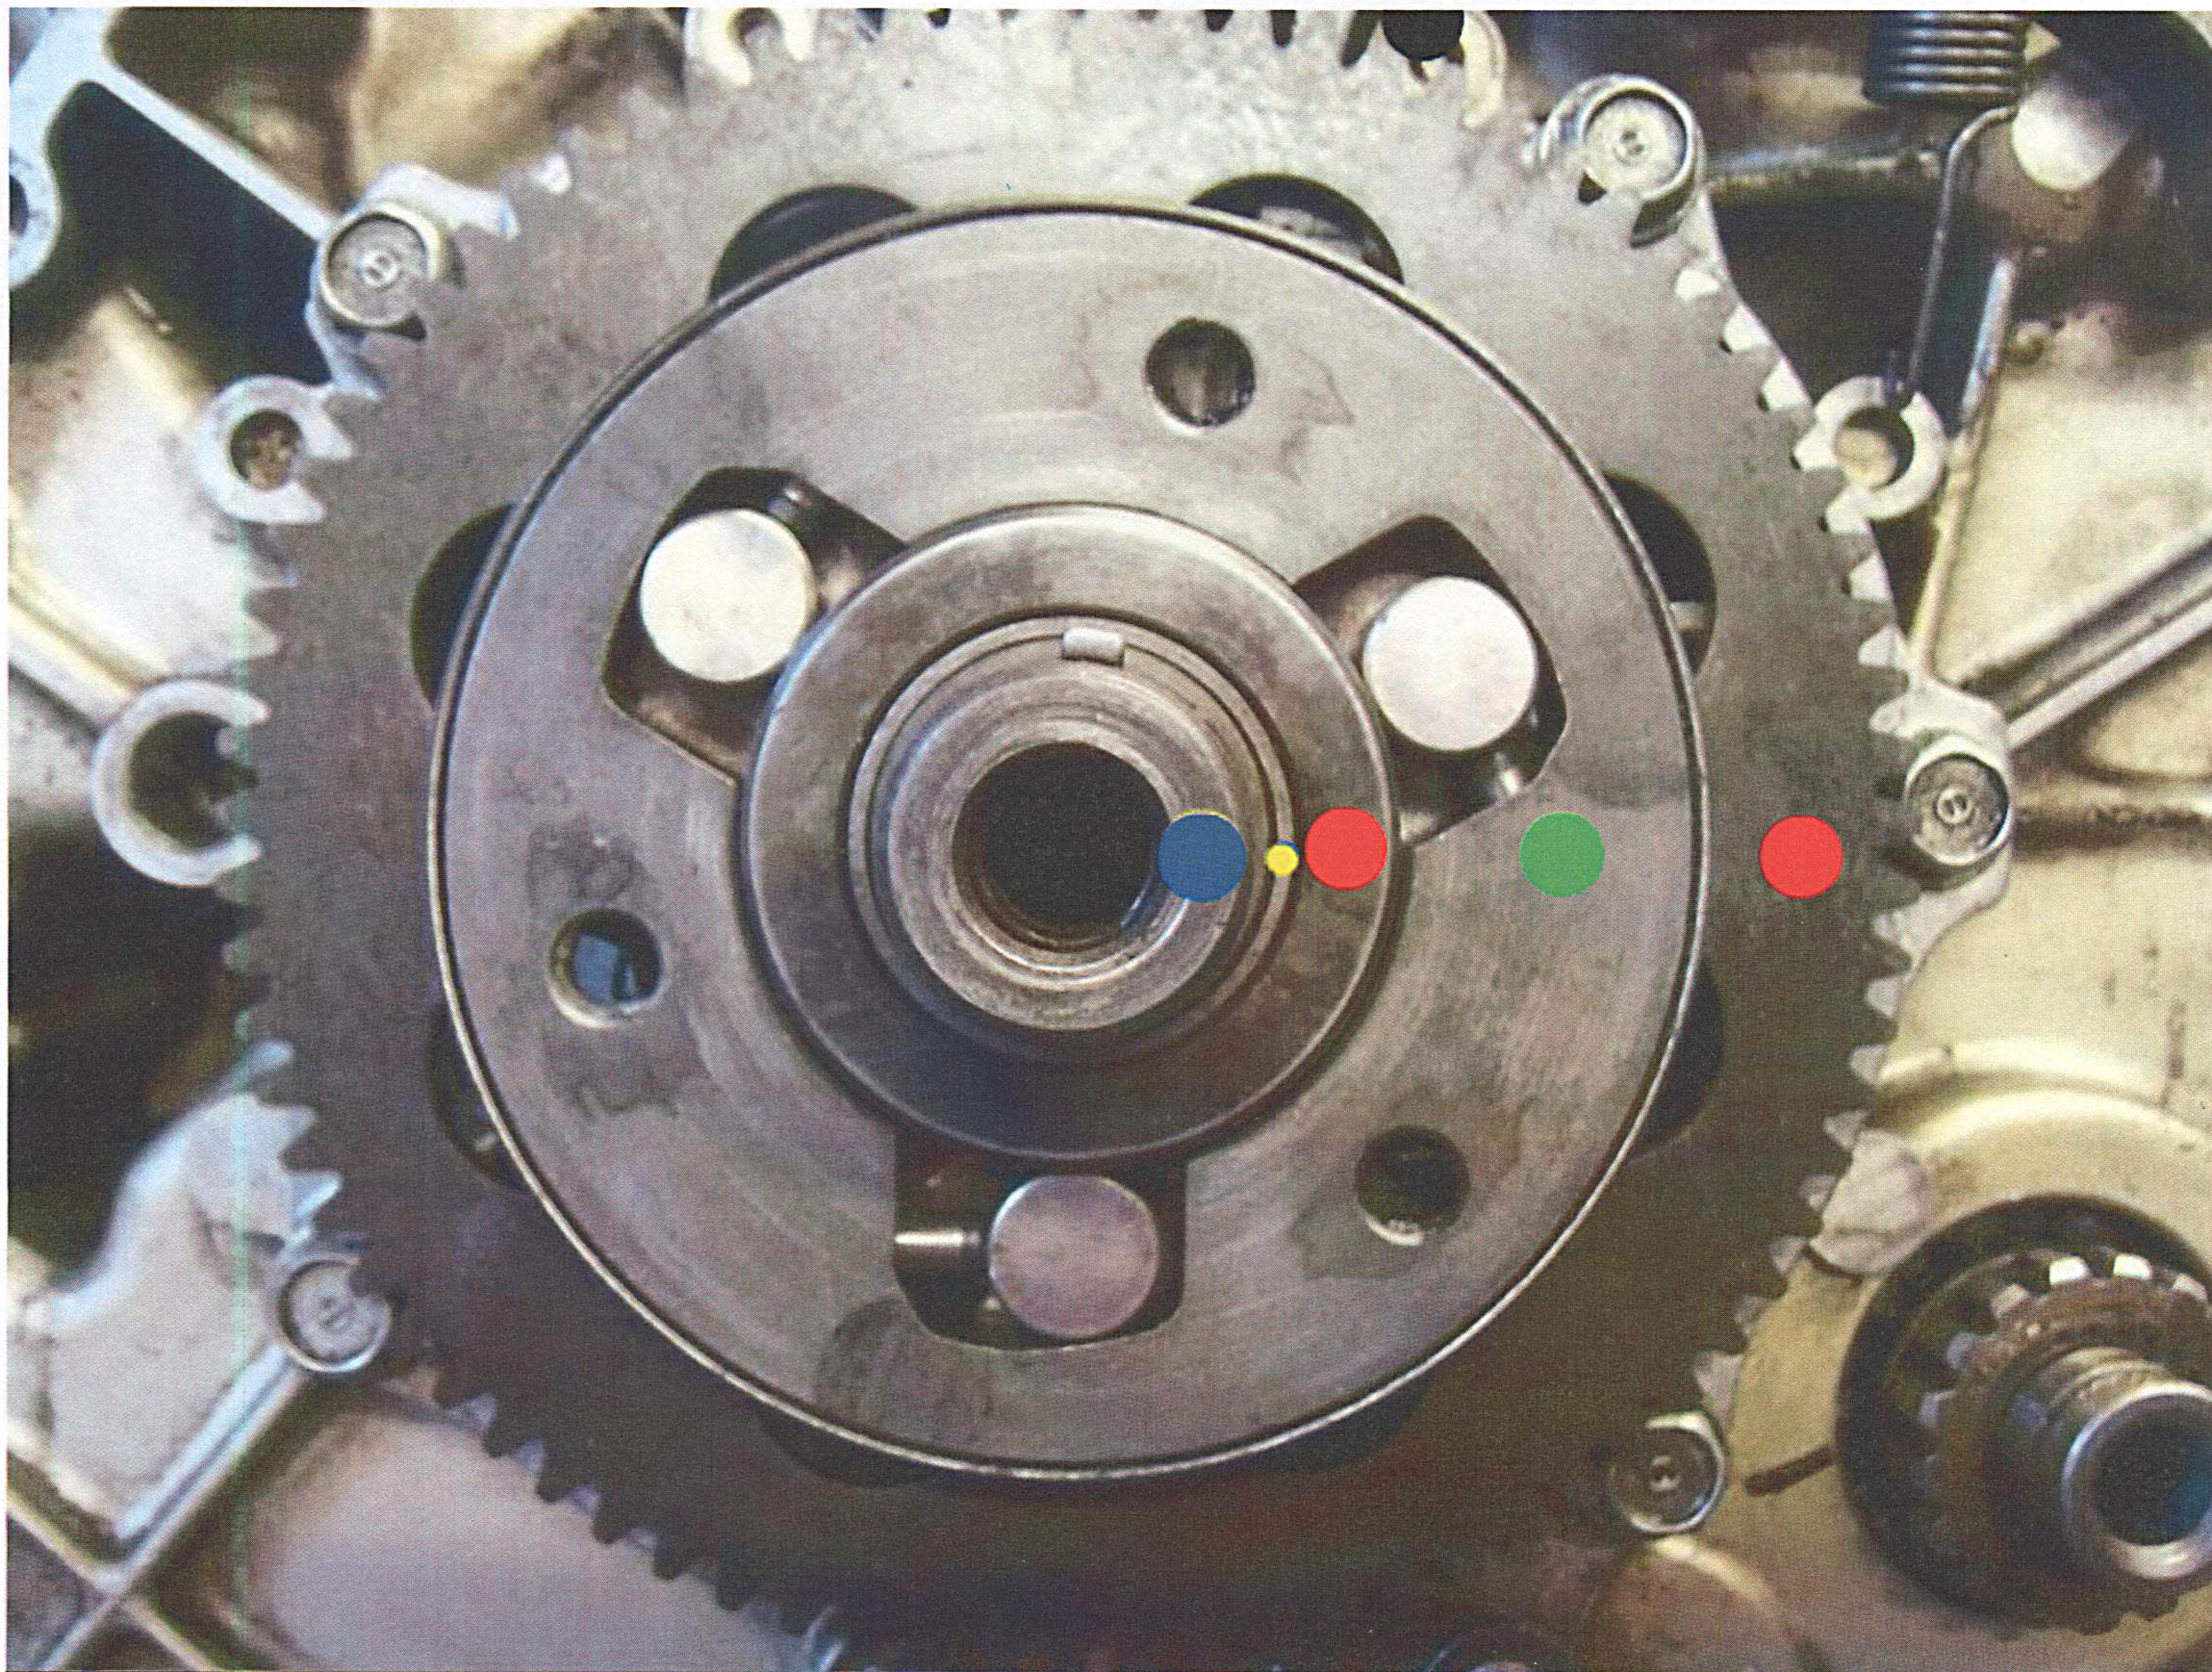
Here`s a view of the starter clutch assembled on the crankshaft, but with the rotor (flywheel) removed. The part marked red is the starter driven gear. It is a one-piece item: the inner dot is the boss onto which the rollers grip and lock the driven gear to the rotor/crank during starting, the outer dot is the `gear part`. Here`s

[a pic](http://i4.photobucket.com/albums/v122/esox/Engines%20and%20parts%20etc/drivengears.jpg) of some removed. The green dot is the starter clutch body which contain the springs, caps and rollers. The yellow dot is the needle roller bearing in which the crankshaft spins while supporting the (stationary) driven gear while the engine is running. Blue dot is the crankshaft with woodruff key visable on the taper at just gone 12 o clock position. The three holes in the starter clutch body are for the Torx bolts that are the only means by which the

starter clutch is bolted to the rotor and thus the crankshaft. These bolts have to withstand all the stresses while cranking and are the parts which get battered if the engine `kicks back`.
