## OFAPARS` V TWINS.

### **Lethargic starter motor.**

### 650 starter motor.

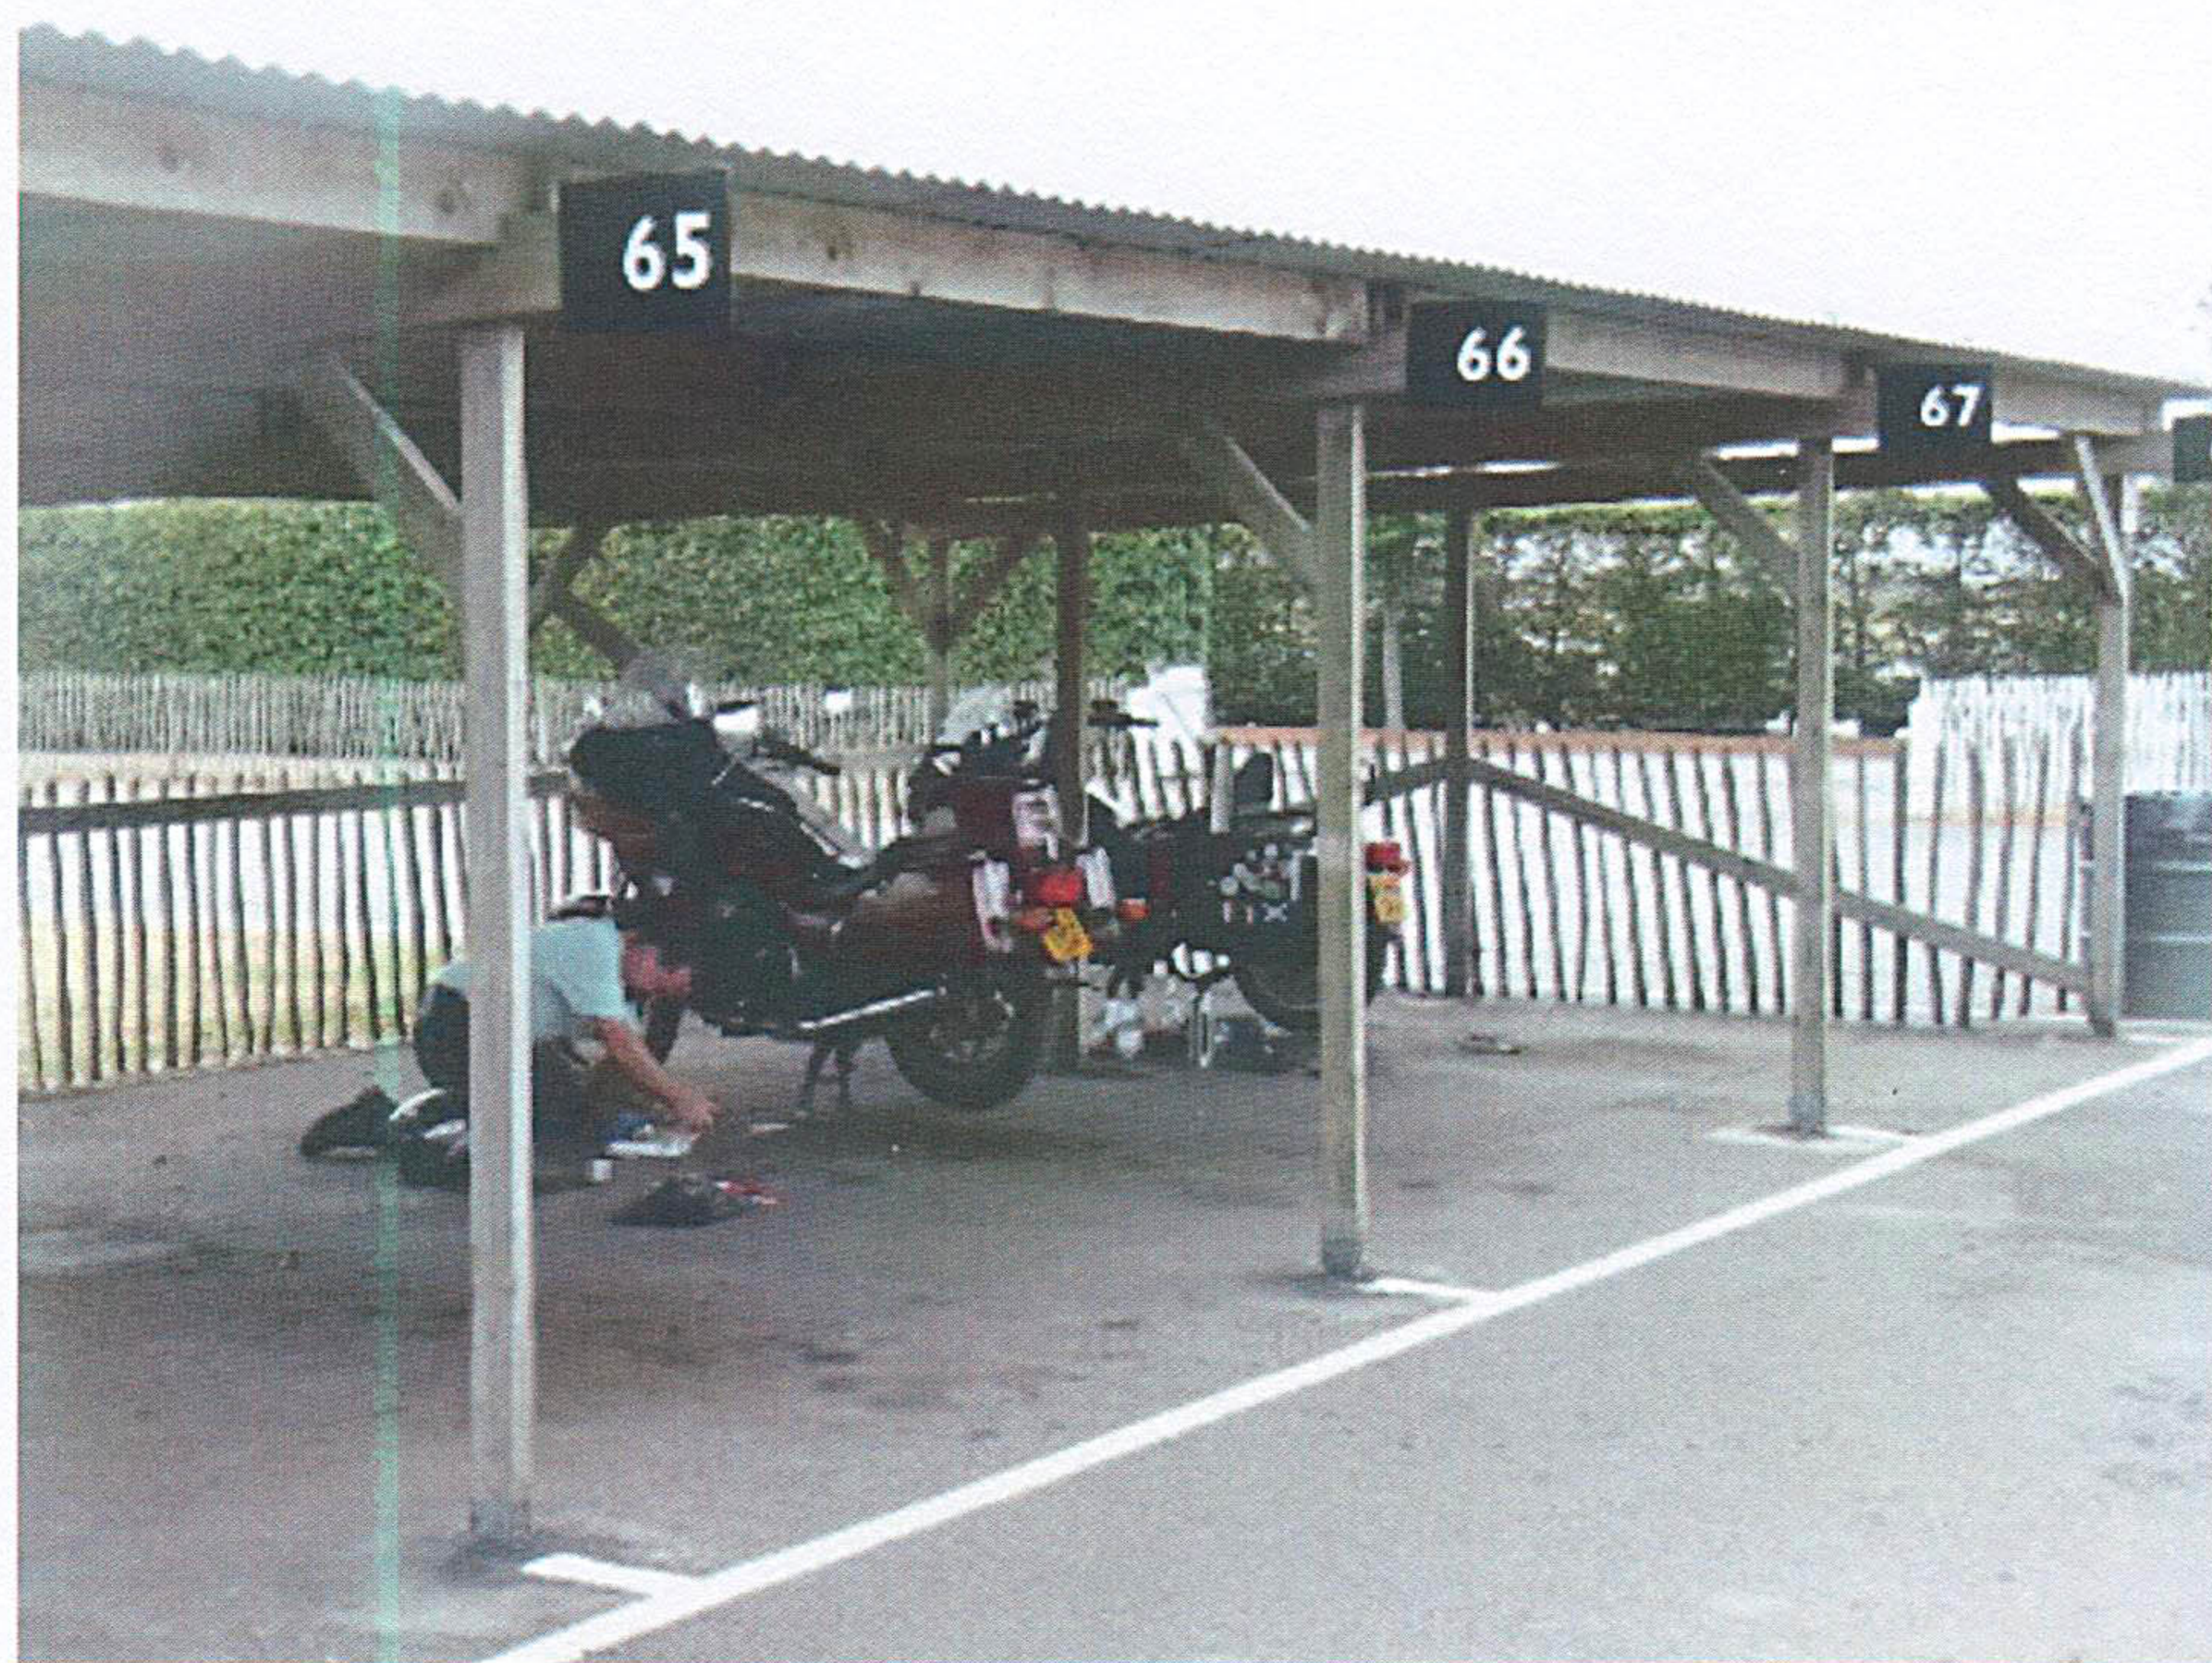
**No 2 test**

Well, that seemed to work, so i prepared another base plate and end cap with the earth strap mod and arranged to meet up with another 650 owner who i knew was experiencing the same `650 starter disease` on his GL. The starter motor surgery took place in the pits area of the historic Goodwood race track in West Sussex;
